Learning from Earthquakes

The M_w 7.6 Western Sumatra Earthquake of September 30, 2009

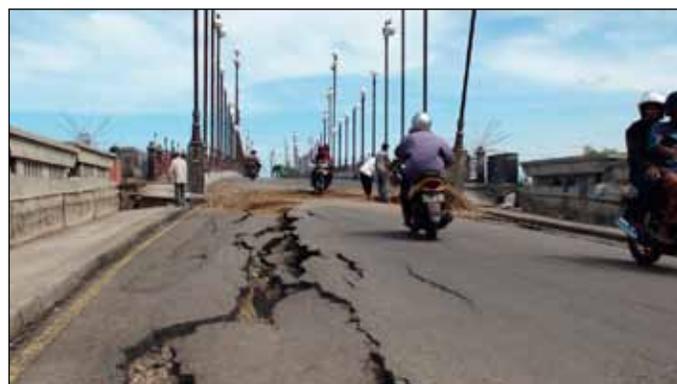
Figure 4. Siti Nurbaya Bridge south approach ramp.

The Siti Nurbaya bridge (in Figure 2) is one of the few bridges outside of the mountain areas that suffered earthquake damage. It is an important link between the low-lying old town of Padang and high ground located to the south, and the bridge approach had ground cracking due to settlement and dynamic densification of fills within the reinforced earth ramp (Figure 4).

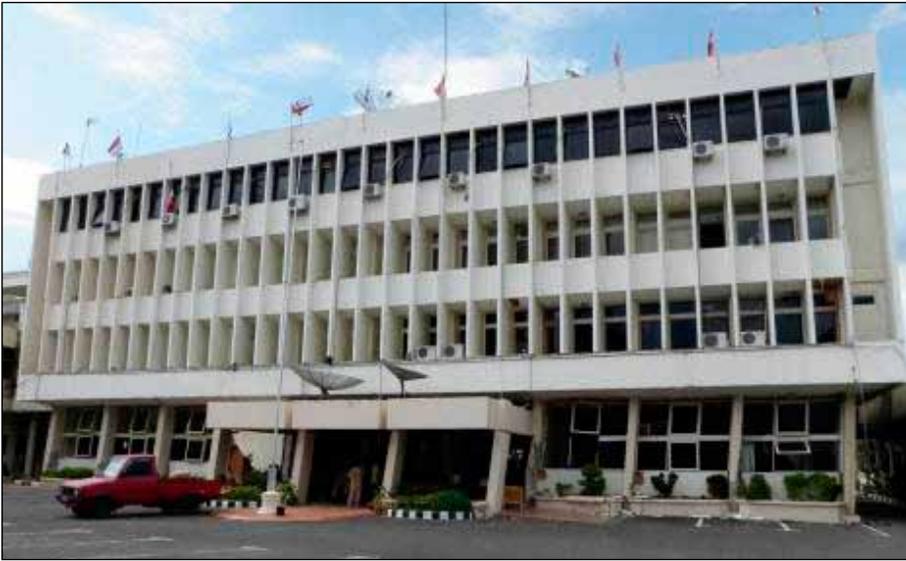
Figure 5. First-story column damage and residual drifts in public works building.

Under a four-story public works building, located 100 m away from the river front, there was liquefaction that may have contributed to the building damage. The building configuration concentrated lateral deformations and residual drift in the first story (Figure 5). Adjacent to the building, fine beach sand spouted out of ground cracks, indicating that liquefaction may have caused foundation movement and increased the demands on the structure. There was ground deformation under several other smaller buildings along the river front and in other isolated parts of Padang.

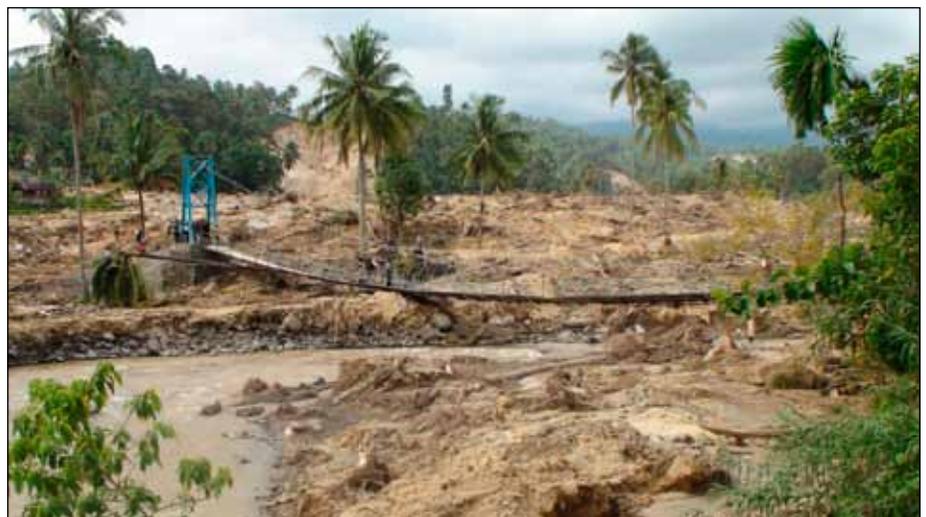
Figure 6. Shallow slope failures and debris flows in rural areas northeast of Padang.

Landslides: At Lubuk Lawe, northeast of Padang and Pariaman, extensive landslides and mud flows buried hundreds of people and demolished at least five villages (Figure 6). Observations of the spoil site showed that the pumiceous tuff originating from late eruptions of the Maninjau caldera was light and porous and had little cohesion. Heavy rain over several days before the earthquake is likely to have saturated the ground, increasing the driving force and weakening the soil resistances, causing the slope to be marginally stable. The flat lands below the hills at the toe of the hills, consisting mainly of loose silt, sand and gravel mixtures, may have also lost lateral support and

contributed to the massive landslides and debris and mud flows. In highland areas the heavy rain and earthquake shaking caused near-surface loose colluvium to slide.

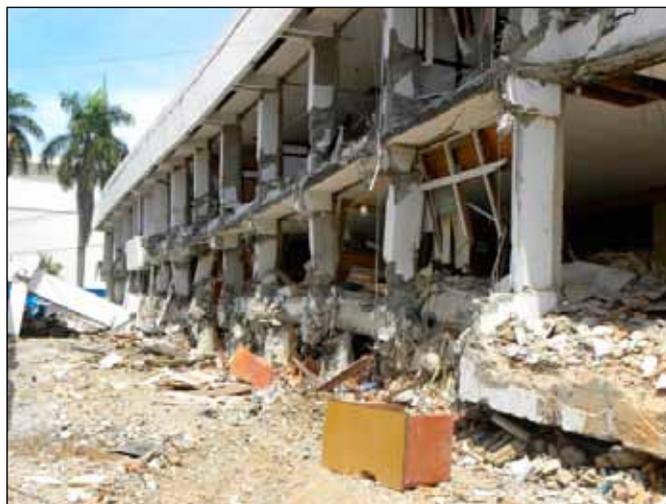
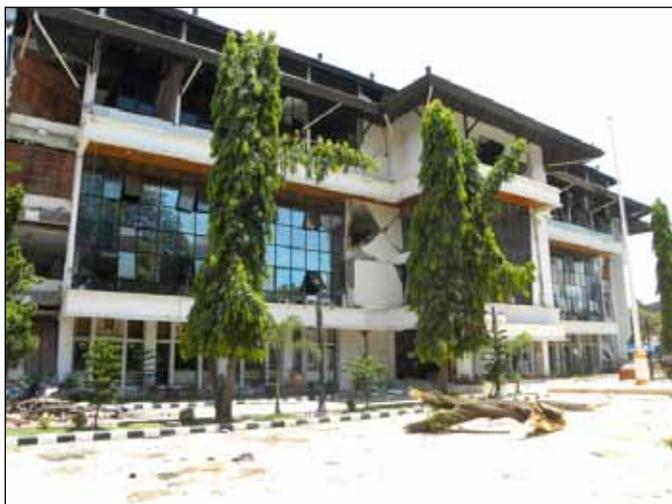
Figure 7. Padang city government buildings, including a collapsed 3-story building (left) and newer 4-story building (right) with extensive nonstructural damage.

The Padang City Government headquarters consists of several buildings, including an old 2-story masonry building that houses the mayor's office and two concrete buildings that house administrative offices. The masonry building, constructed by the Dutch in 1906, had moderate damage to the masonry walls, including a couple that failed out-of-plane. The 3-story city planning office, constructed in 1977, had a first-story collapse due to a combination of weak columns and seismically deficient steel reinforcement (Figure 7, left). This building had been moderately damaged during an earthquake in 2007, but no investigation or retrofit followed. The office staff had left for the day and the building was unoccupied when the earthquake struck. A newer 4-story office building survived the earthquake with only minor damage to the concrete frame, but with extensive damage to the façade, interior partitions, and the third-floor ceiling (Figure 7, right). Damage to the third-floor ceiling and

walls was exacerbated by the steel roof truss that provided limited diaphragm stiffness.

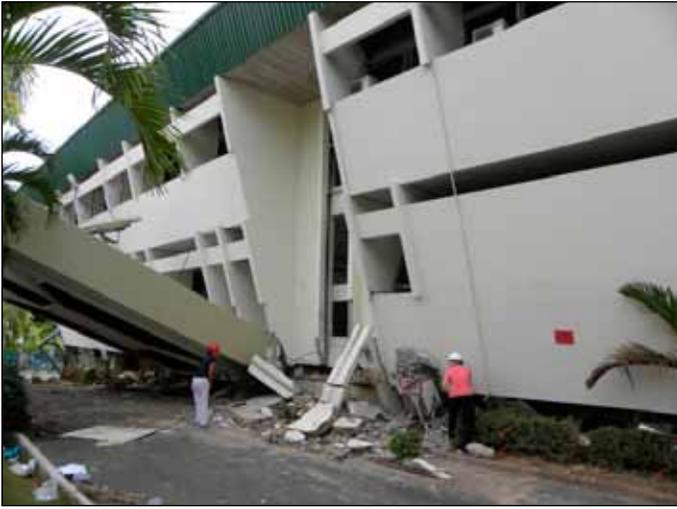
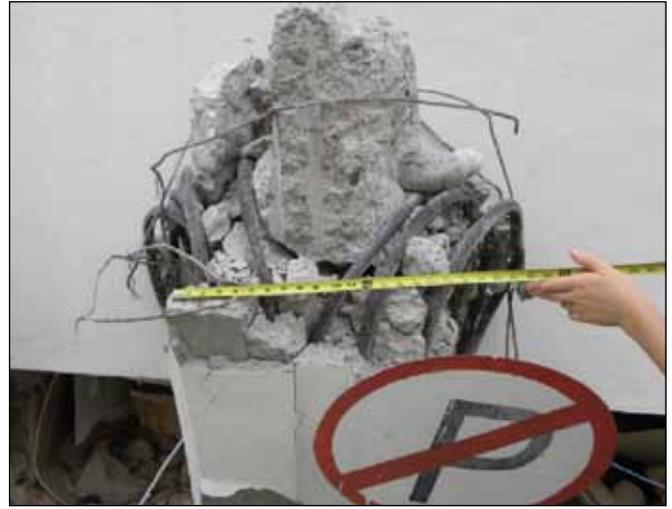
Figure 8. First-floor collapse in 3-story office of the Provincial West Sumatra Planning Building, constructed in 1983.

The first story collapsed in the 3-story office of the West Sumatra Planning Department (Figure 8), built in 1983. The inward taper to the façade and concrete walls created a weak first story that collapsed with about 250 mm of lateral displacement (6% drift). Large river rock aggregate (up to 120 mm) in the concrete had limited bond to the cement and sand matrix. According to security personnel, 80 people were in the building during the earthquake, two of whom died while evacuating from the 2nd floor.

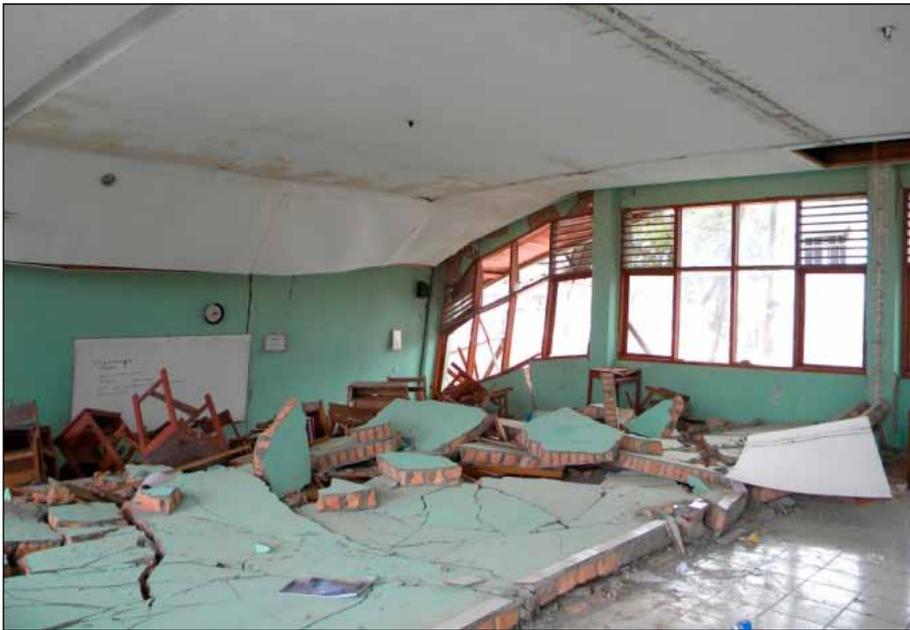
Figure 9. Partially collapsed SMK 9 Negeri High School.

Ambacang Hotel. In the largest of the three buildings, a 3-story concrete frame with brick infill walls built in 1996, interior brick partitions failed (Figure 9) and the third floor collapsed partially. School officials reported that 200 students were present at the time of the earthquake and that most escaped by running out of the building. Two people died and five others were injured. Displaced classes were being held in a tent, and workers were in the process of building a temporary wood building to house classes until the permanent buildings were reconstructed.

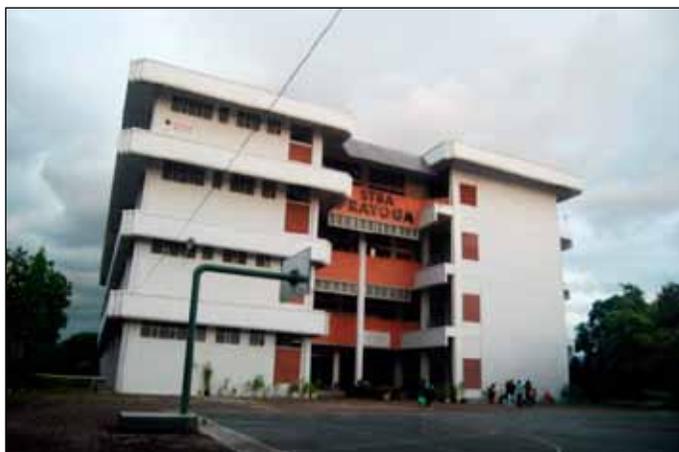
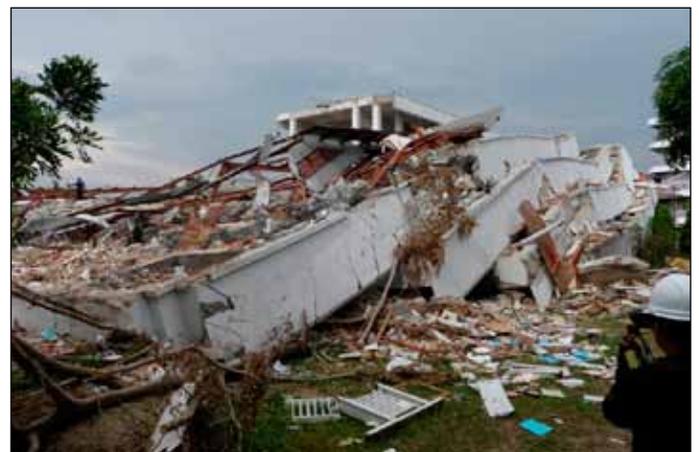
The 4-story STBA Prayoga Language College building (Figure 10) was located close to the coast and had been identified for vertical tsunami evacuation. Constructed in 2001, the building consisted of two structures, separated by an expansion joint, one of which collapsed completely. A class of 15 people was in session at the time of the earthquake, 13 of whom perished. According to the survivors, the students were on the 2nd floor and attempted escape from exits at opposite sides of the building before being trapped by the collapse. The portion of the building left standing revealed a concrete frame with tall story heights, deep beams and slender

der columns, which made the building prone to a multistory sideway collapse. Pounding between the adjacent buildings may also have contributed to the collapse.

Figure 10. Before and after pictures of 4-story STBA Prayoga school building.

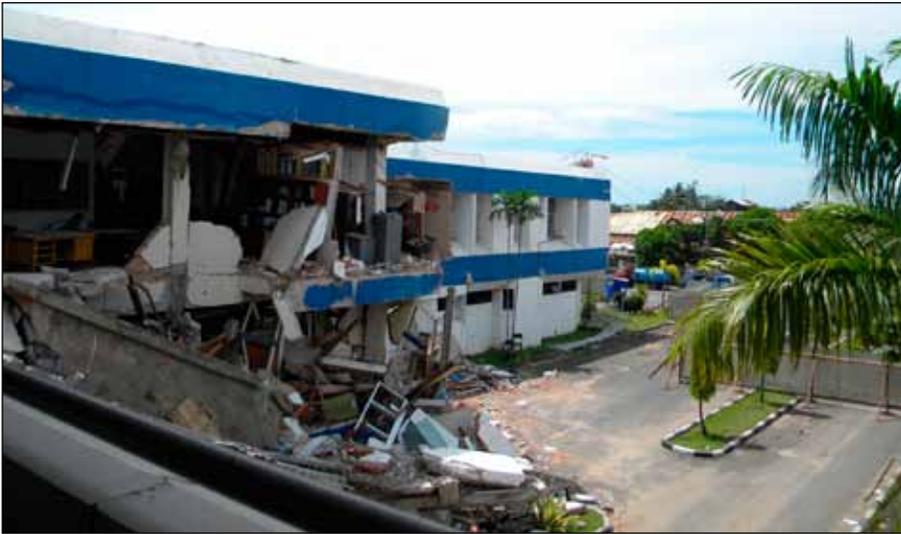
Figure 11. Collapsed outpatient building of the M. Djamil Hospital.

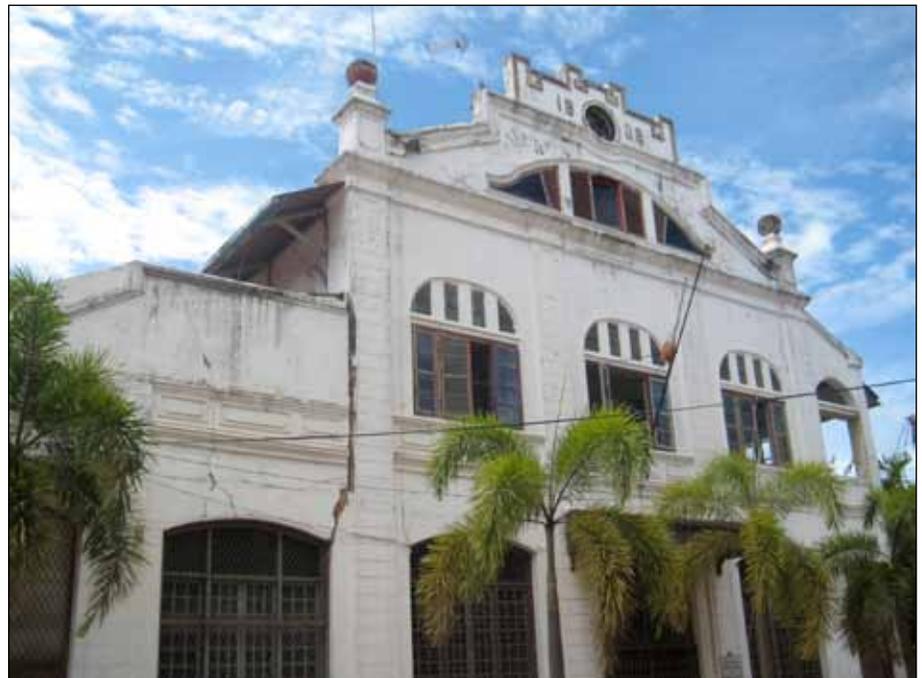
Commercial buildings: Padang was a Dutch colonial trading center in the 17th century. Evidence of this period is found along the Batang Arau River, where there are a number of 100-300 year old buildings from the Dutch era (Figure 12). While most of the old Dutch buildings survived, significant repairs will be necessary to restore

Figure 12. Masonry building constructed by the Dutch in 1908.

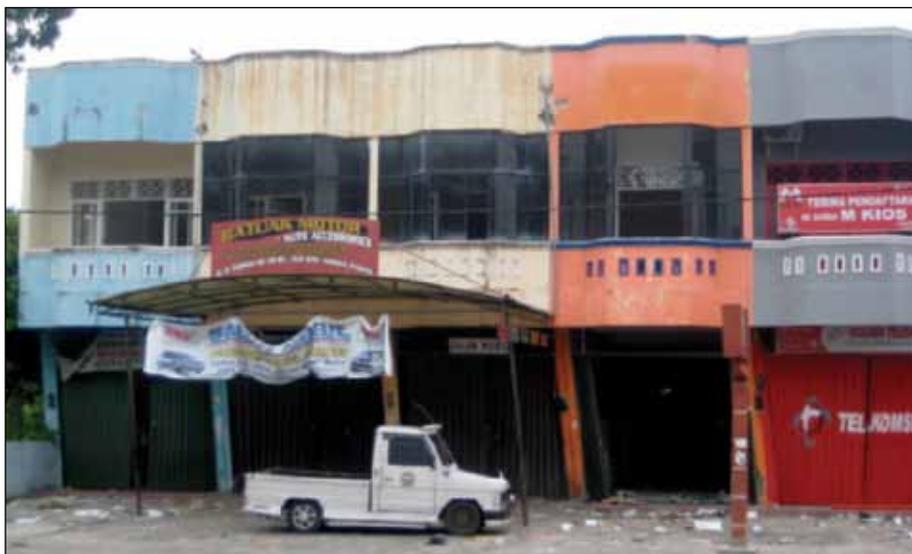
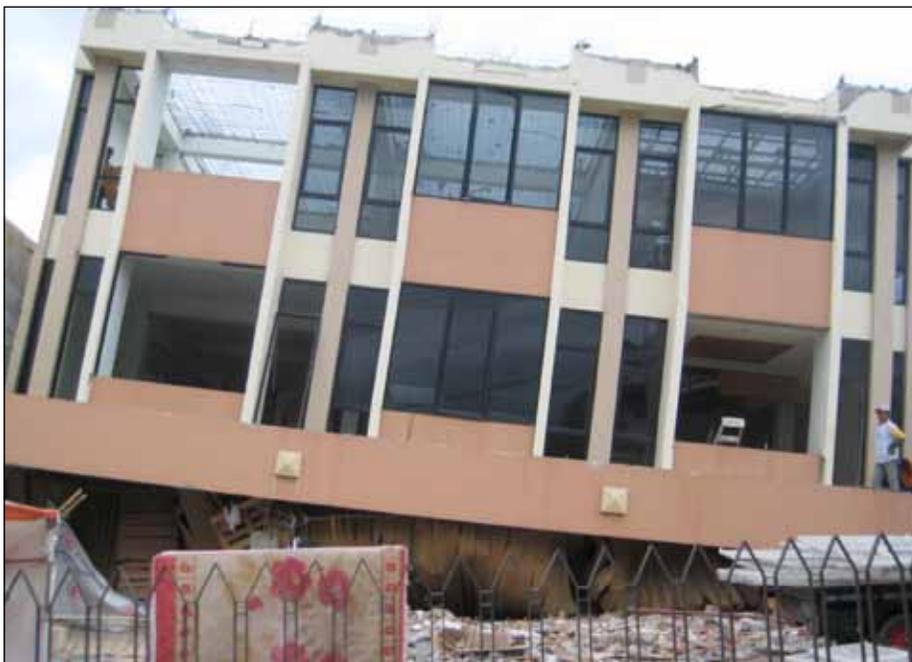
The typical ruko layout includes an open store front and large window openings at the front elevation, with concrete frames and exterior brick infill walls on all sides and interior brick infill walls between units (Figure 13, top). The brick infill wall layout causes the buildings to be stiff in the transverse direction and flexible along the front elevation. While the majority of these buildings showed no signs of structural damage, there were a number with significant residual drift and hinging at the top of the first-story columns. A number of collapsed rukos were observed, almost exclusively caused by a first-story mechanism and column failure (Figure 13, bottom). In many cases, they had been renovated to add ad-

Figure 13. ▲ Damage to home shops that are common in Padang. ▼

ditional floors without any seismic design or strengthening.

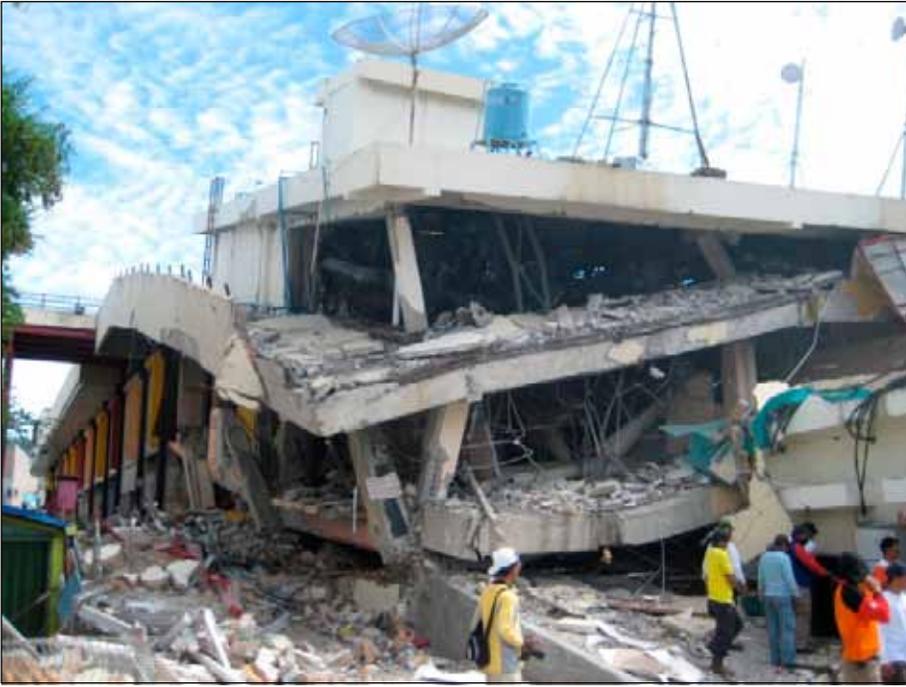
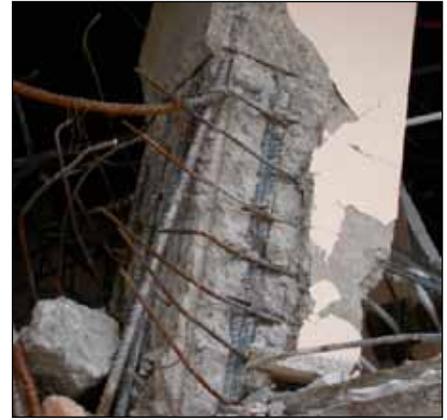
Raya, a 3-story structure built in 2005, suffered significant brick infill wall damage on all four sides and major nonstructural damage to ceilings and equipment (Figure 14). The rear corner of the structure collapsed, while adjacent columns were damaged at the beam-column joint but remained standing. On the roof above the collapsed area, several large tanks and a penthouse may have caused torsional behavior that contributed to the collapse. While the column reinforcing ties were closely spaced, the ties had 90 degree hooks

all aligned along one corner; that conduced to unzipping the ties up the column.

◀ **Figure 14.** ▲
Collapsed portion of three-story
Sentral Plaza Raya.

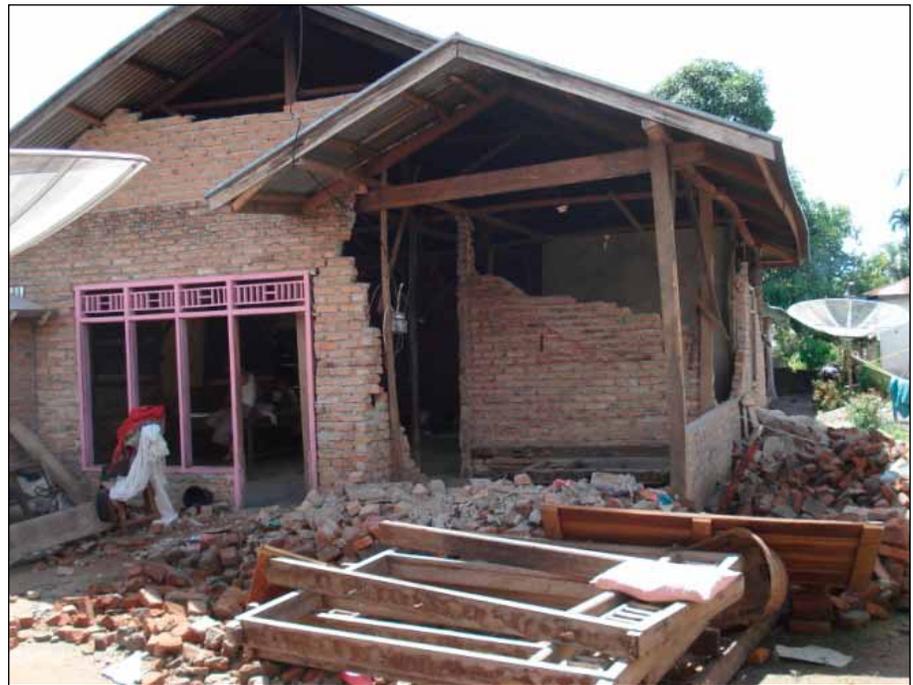
Figure 15. Unreinforced brick masonry house with both in-plane and out of plane wall failures.

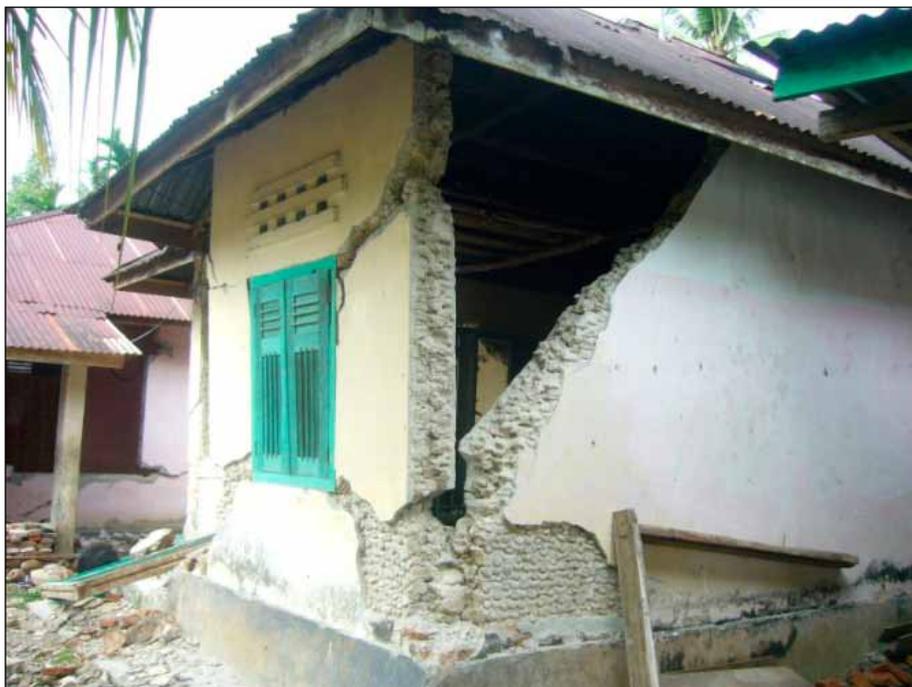
Figure 16. Unreinforced river stone masonry house with hipped roof, Padang Bintungan.

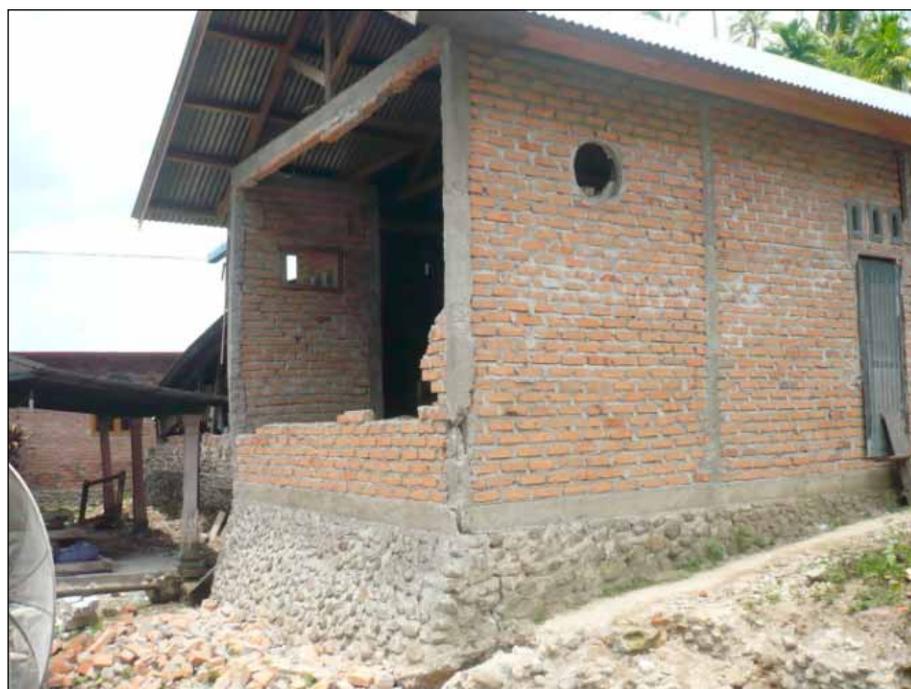
Figure 17. Out-of-plane collapse of confined masonry wall, exacerbated by foundation settlement, Lansano, Kampong Dalam.

Confined masonry: Confined masonry is commonly used for new houses in rural areas of Indonesia, although it was less prevalent in areas affected by this earthquake. Observed damage to confined masonry was less severe than to unreinforced masonry houses. In one confined masonry house (Figure 17) where damage was observed, the out-of-plane wall failure was attributed to the lack of anchors between the concrete columns and brick infill, and deformations induced by foundation settlement. With proper detailing, such failures should be avoidable.
