# The *M<sub>W</sub>* 7.0 Haiti Earthquake of January 12, 2010: USGS/EERI Advance Reconnaissance Team Report

By Marc O. Eberhard, Steven Baldridge, Justin Marshall, Walter Mooney, and Glenn J. Rix

Open-File Report 2010-1048

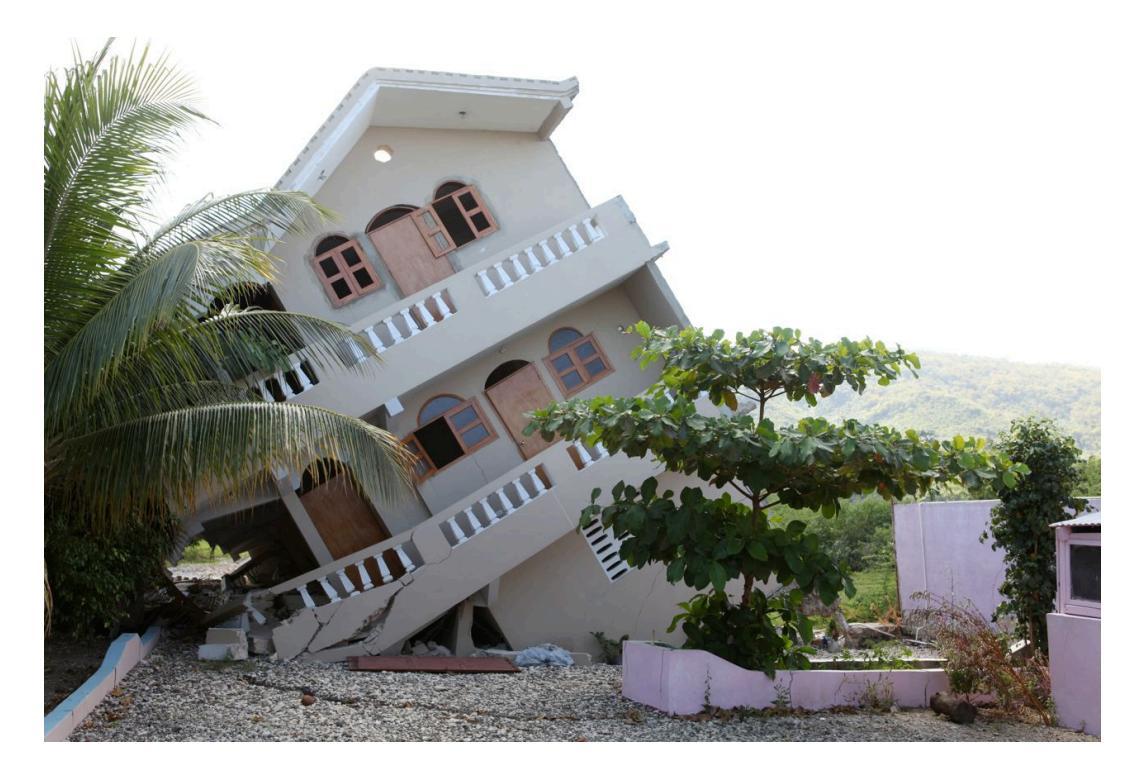
Other less severe liquefaction-related features were observed in the alluvial plain surrounding the city of Léogâne. Figure 6 shows the failure of a structure located about 75 m (246 ft) from the shoreline at 18.446323° N, 72.686259° W. There were several sand boils nearby, the largest of which measured approximately 4 m (13 ft) in diameter. Based on discussions with others who observed this structure (Ellen Rathje and Russell Green, personal commun., 2010), it is likely that a combination of structural and foundation failures contributed to the collapse of the structure.

Figure 6. Combined structural and foundation failure southwest of Léogâne.

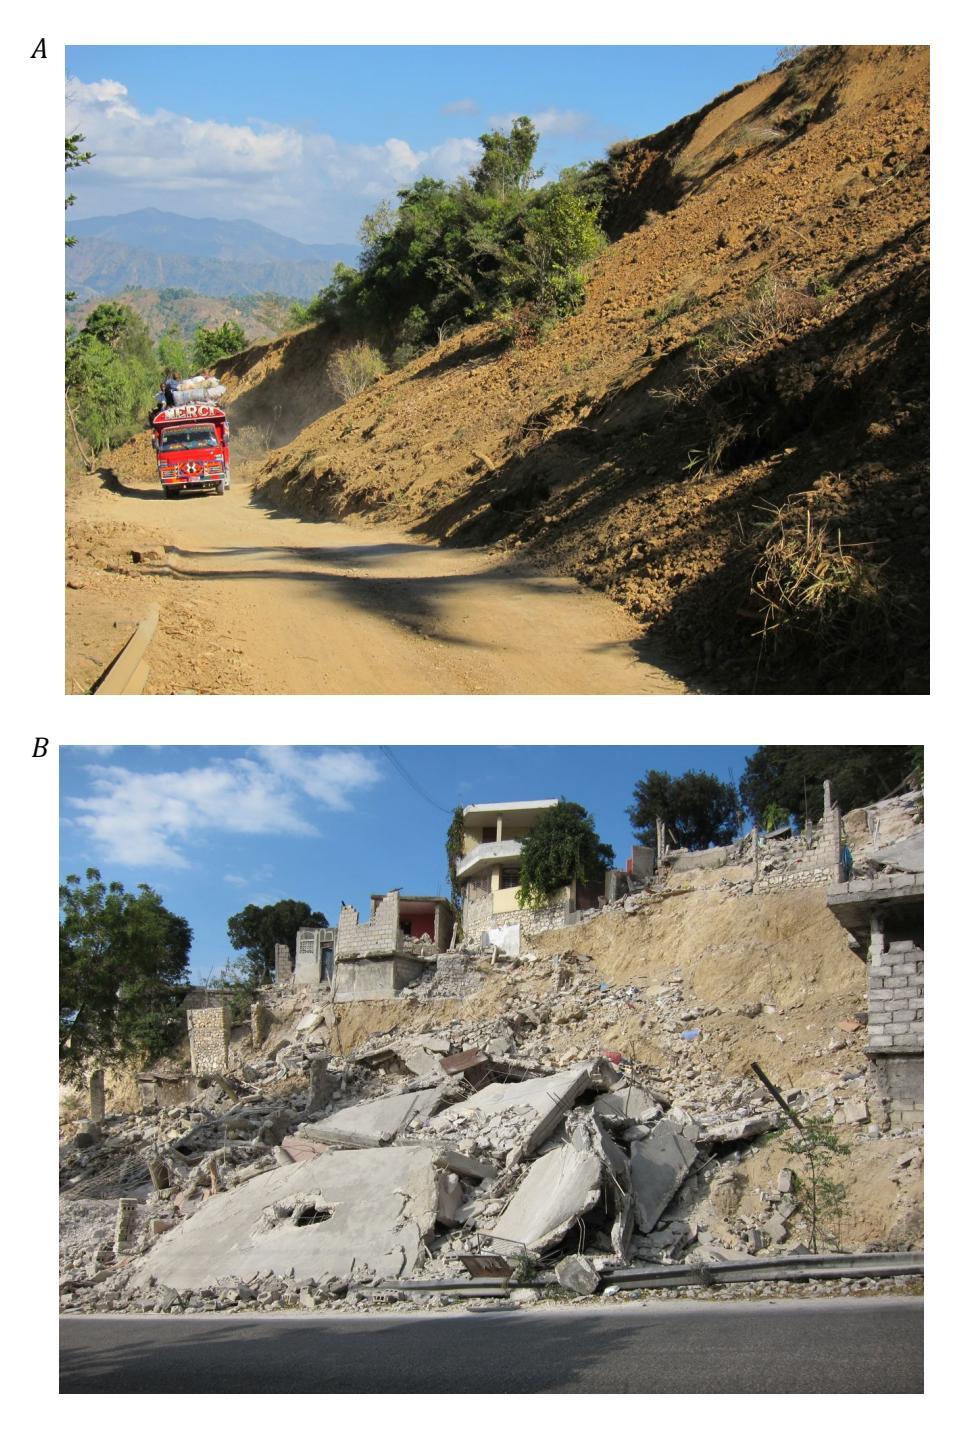
We observed a large number of landslides along Highway 204 in the mountainous area approximately 10-15 km southwest of the epicenter. Most of these landslides occurred in cut slopes along the highway (fig. 7*A*). We did not observe many landslides in natural slopes away from the highway. We also observed several landslides in the foothills of the La Selle mountains between downtown Port-au-Prince and Pétion-Ville. Figure 7*B* shows an example of one such landslide that destroyed several homes on top of the slope.

Figure 7. Landslides (A) along Highway 204 and (B) near Pétion-Ville.

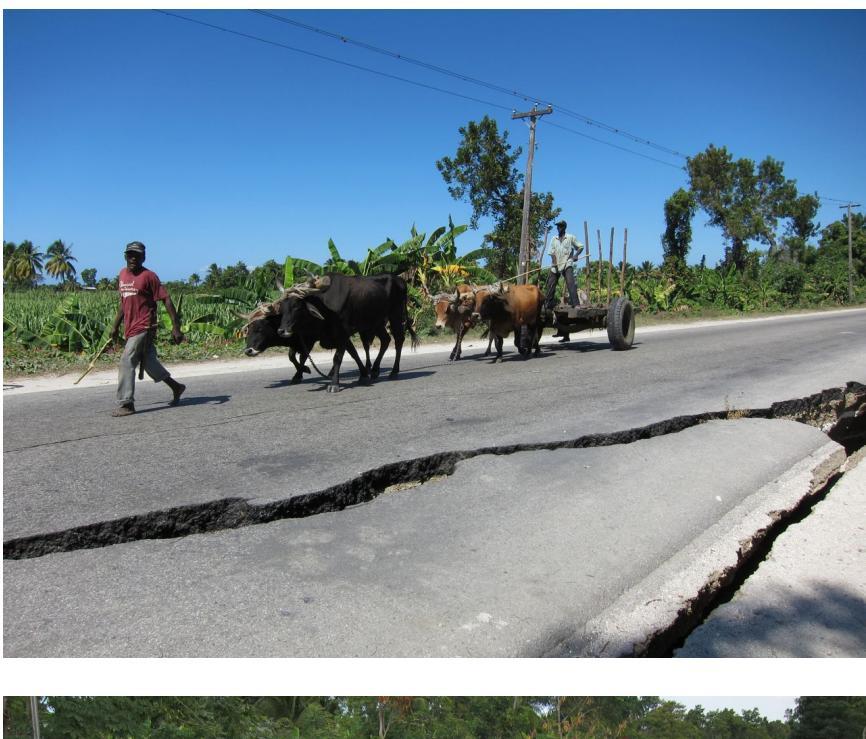
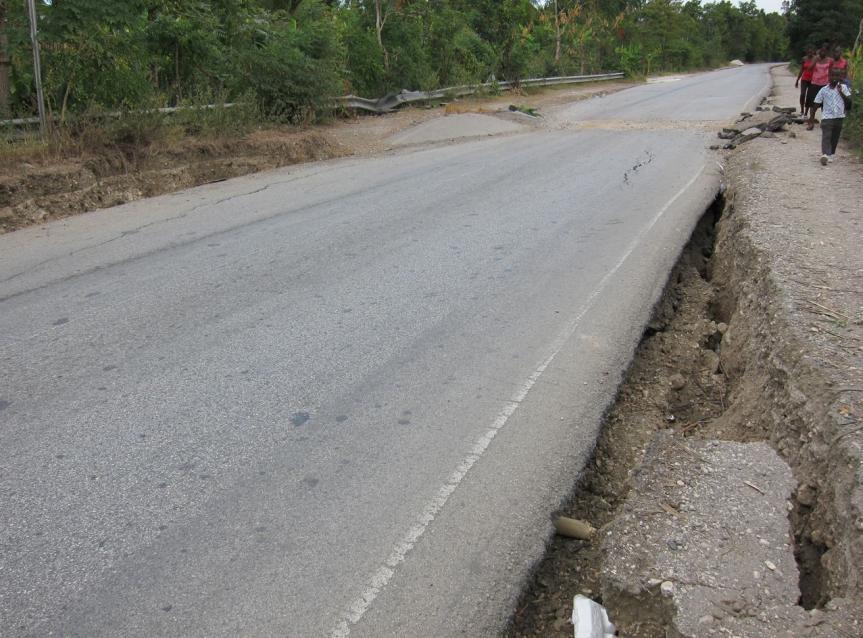
Two failures that caused damage to the pavement were observed along Nationale No. 2 west of the epicenter where the road is constructed on an embankment above low-lying coastal areas. In the first case (18.473550° N, 72.632383° W), the pavement damage appears to have been caused by a slope failure (fig. 8*A*). The cause of damage in the second case (18.423130° N, 72.724660° W) is more complex and may be the result of dynamic densification of the fill because the pavement has settled by approximately 1 m (3.3 ft) (fig. 8*B*).

Figure 8. Roadway embankment failures.

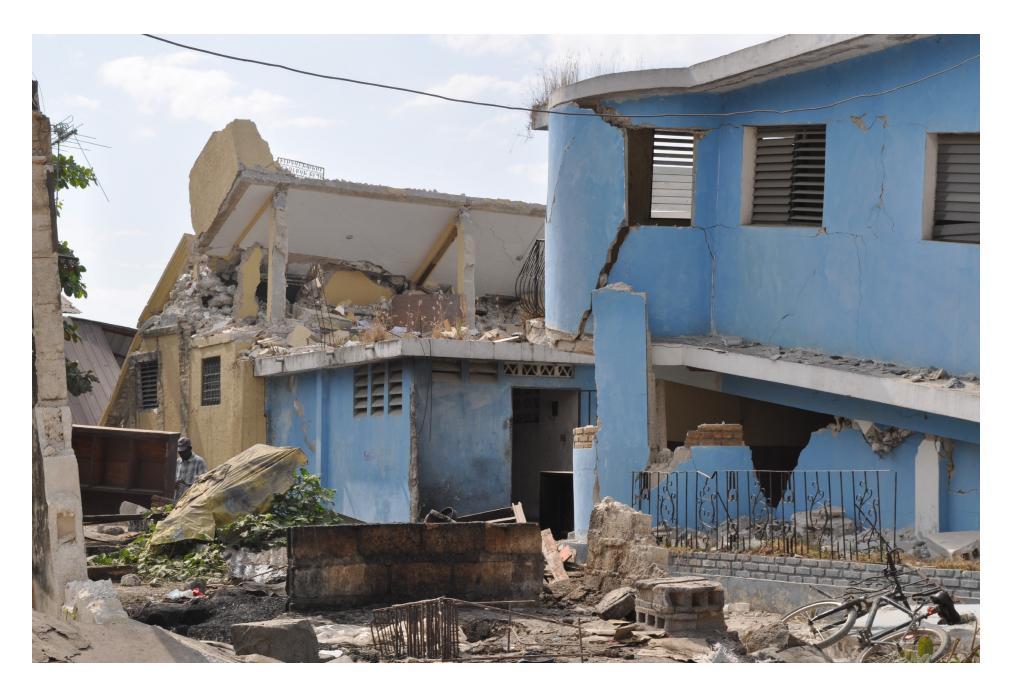
In contrast, there were numerous examples of severe damage and collapse to residences with heavy concrete slab floors and roofs (for example, fig. 10).

Figure 10. Partial collapse of residential building.

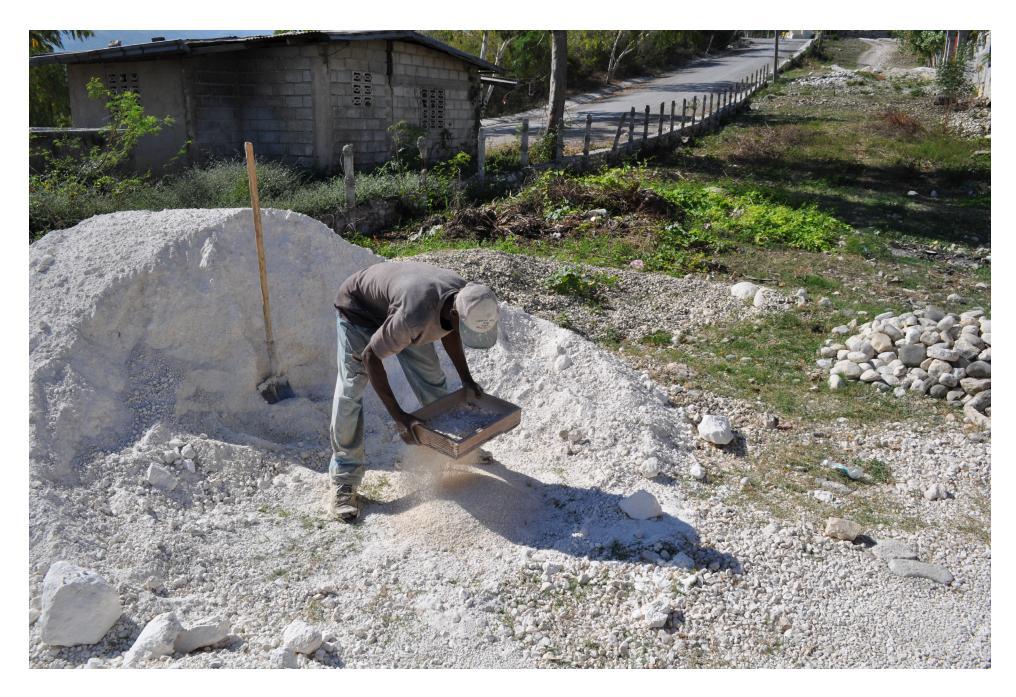
- We observed concrete and concrete block being made at several sites. The site materials appeared to be graded on site with a hand sieve to create the aggregate (fig. 11) and mixed on the ground (or in a wheelbarrow) with cement and water to create mortar or concrete mix. It was not unusual to see pockets of loose aggregate in the concrete, indicating a stiff and/or poor mix. The concrete and mortar often appeared to be of poor quality.

Figure 11. Hand sieving aggregate on site for mortar.

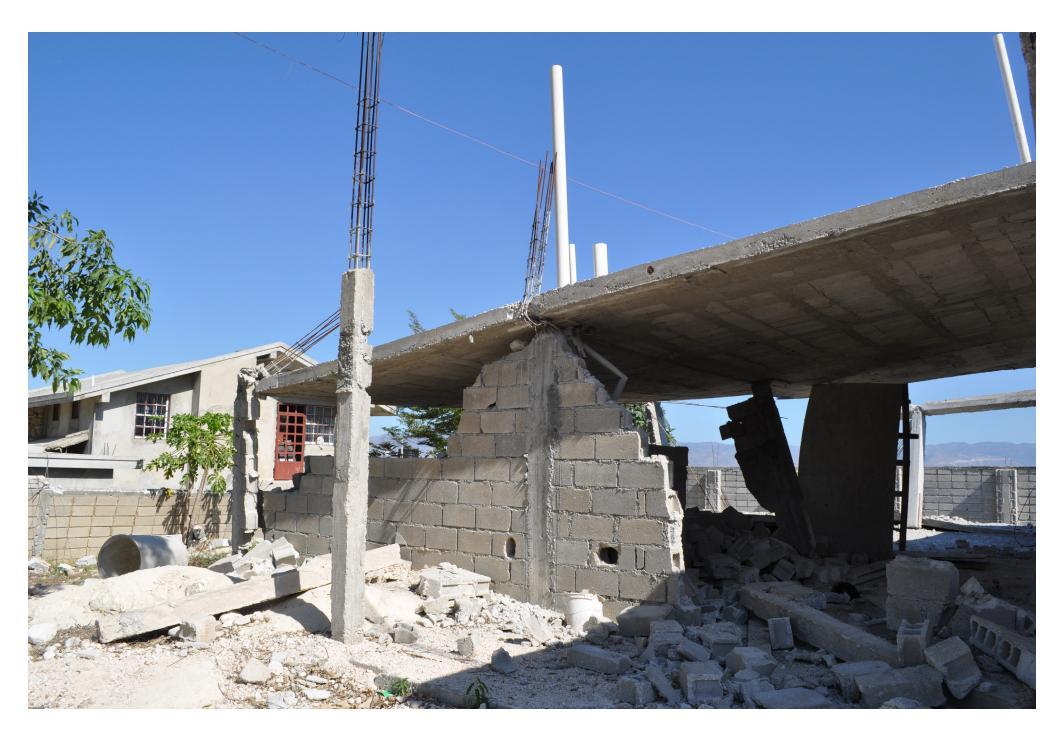
Figure 13. Partial collapse of residential building under construction.

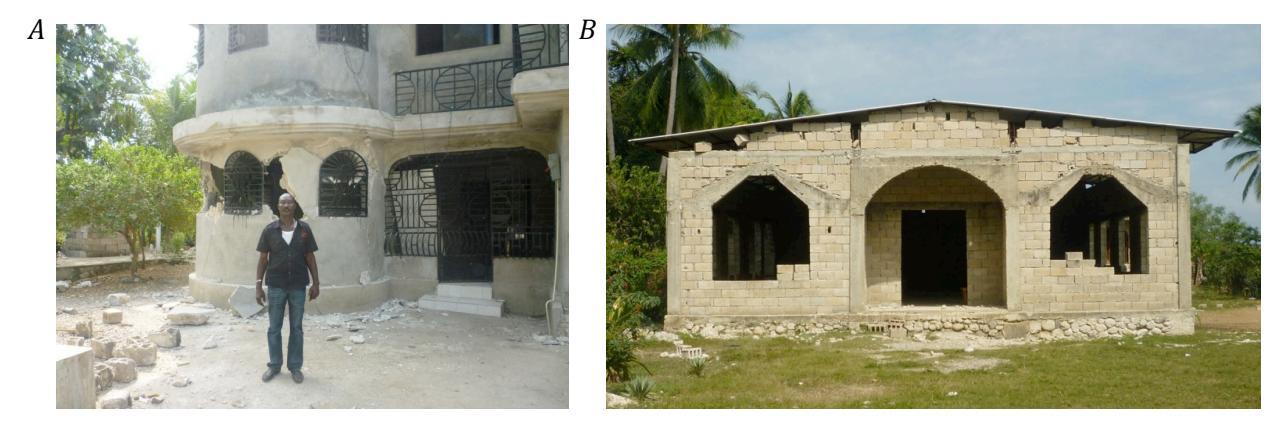
Two adjacent structures located in a hamlet near Léogâne (18.517586° N, 72.572742° W) illustrate the important benefits of having a low weight, particularly for relatively brittle structures built without consideration of earthquake performance. The first, a two-story, concrete bearing-wall house (constructed by the owner), suffered severe damage to all of its first-story walls, particularly on the sides with multiple openings (fig. 14*A*). The adjacent, one-story church, with a light-metal roof supported by masonry walls, appeared to be constructed with materials of poorer quality, but it fared much better during the earthquake (fig. 14*B*).

**Figure 14.** Adjacent rural structures near Léogâne (*A*) concrete-bearing wall house and (*B*) church with masonry walls and light-metal roof.

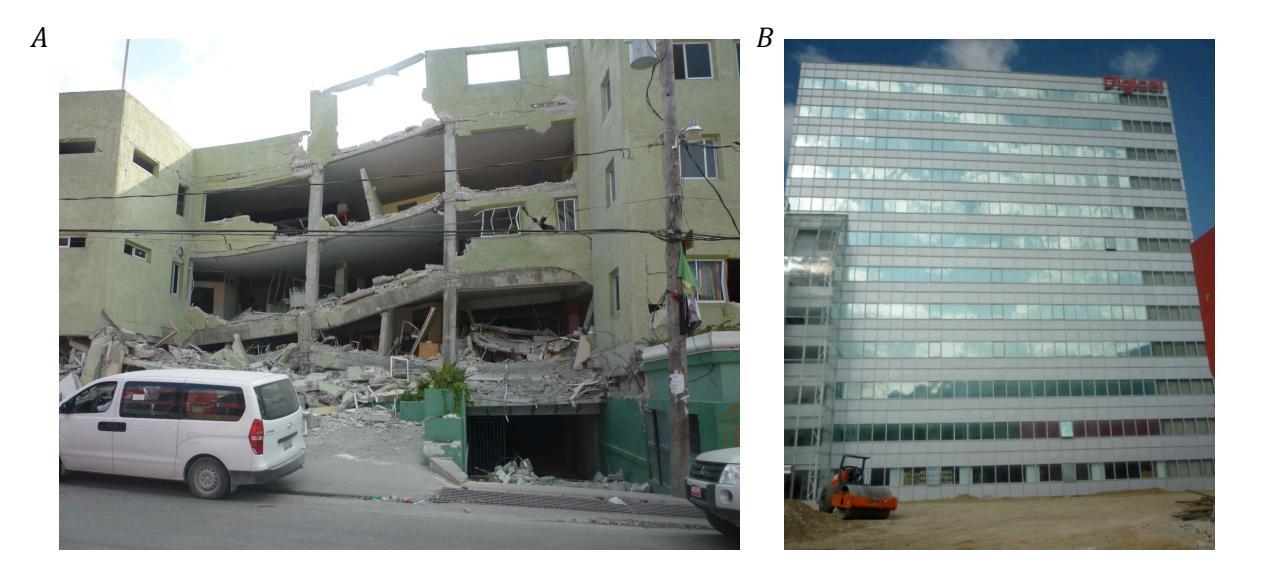
Figure 15*A* shows the collapse of the Turgeau Hospital, whose lateral-force resistance was provided by a reinforced concrete frame with masonry infill. As with numerous other structures we observed, the columns and joints had little transverse reinforcement. The new Digicel building across the street (18.532729° N, 72.323235° W) appeared to be nearly undamaged, with slight damage to a few windows (fig. 15*B*). The fundamental period of the Digicel building was likely much larger than that of the apartment building, so the seismic demands would have differed also. Nonetheless, the stark difference in performance suggests that the severe damage to numerous buildings could have been avoided with greater attention to seismic performance.

**Figure 15**. Damage to two structures across the street from one another in Port-au-Prince. *A*, Reinforced concrete frame with masonry infill. *B*, New Digicel building under construction appears to be nearly undamaged.

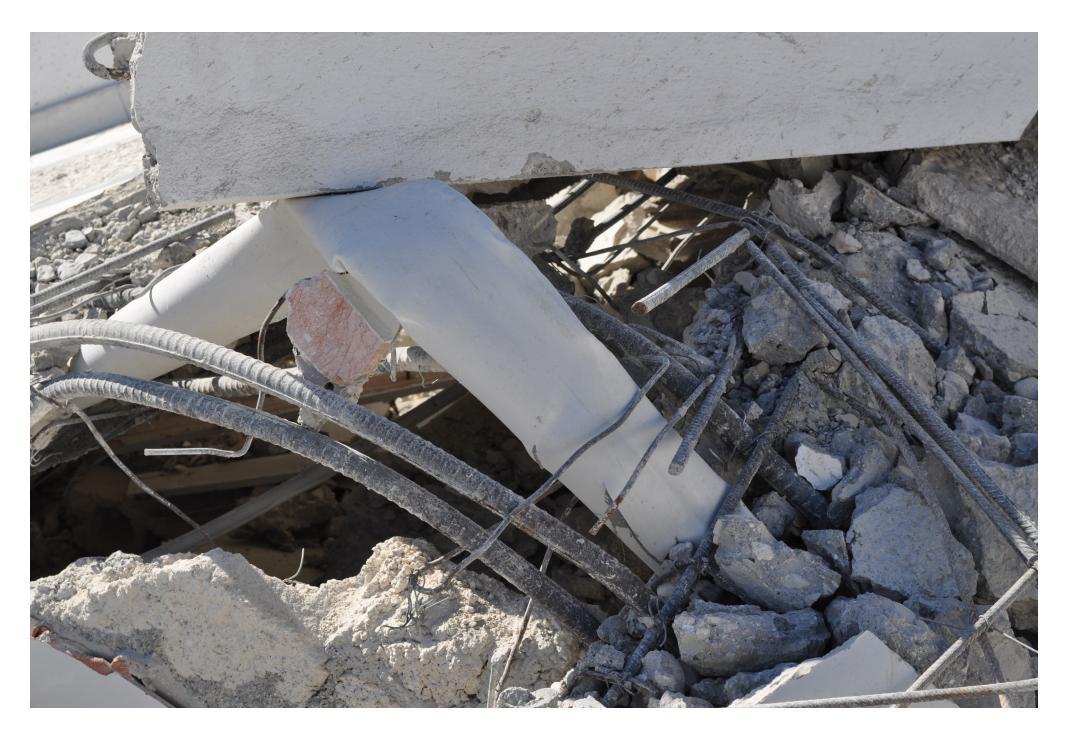
seismic detailing, a mixture of smooth and deformed reinforcing bars with insufficient hook lengths, and questionable concrete quality (figs. 17, 18, and 19). We obtained samples of concrete and reinforcing steel from the Hotel Montana for later strength testing. Only small portions of the hotel remained intact (fig. 20).

**Figure 17.** Remains of the top of a column at the Hotel Montana. Note the large embedded PVC pipe and the small #2 smooth column ties.

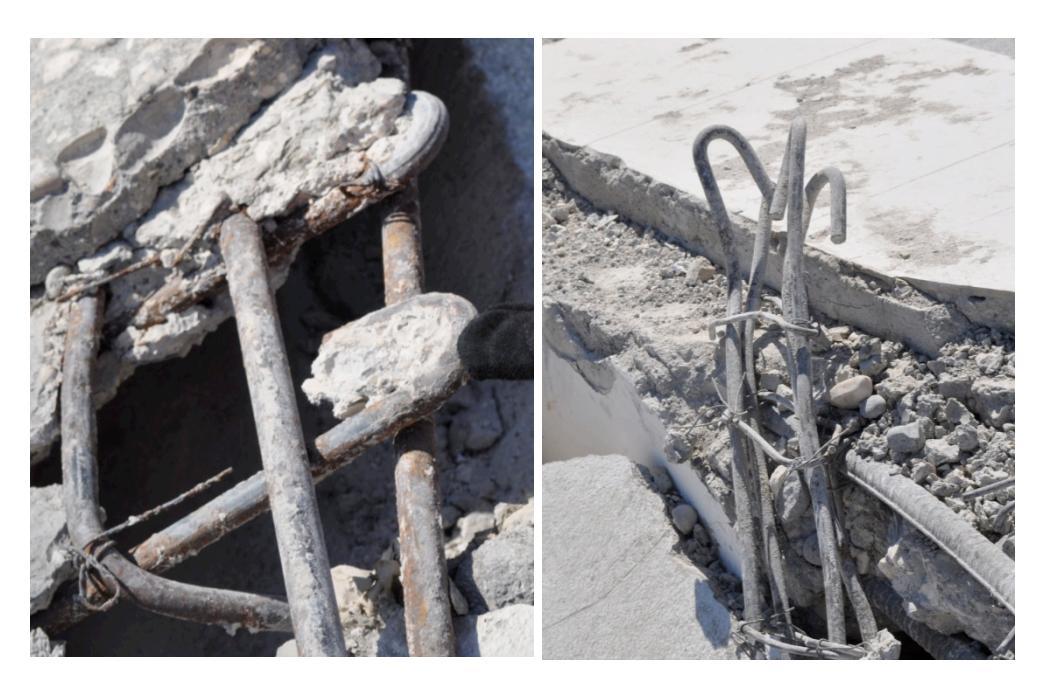
**Figure 18.** Smooth reinforcing steel was used in both slabs (left) and columns (right) at the Hotel Montana. The hook lengths on reinforcing steel were only 50 to 60 percent of ACI-required lengths.

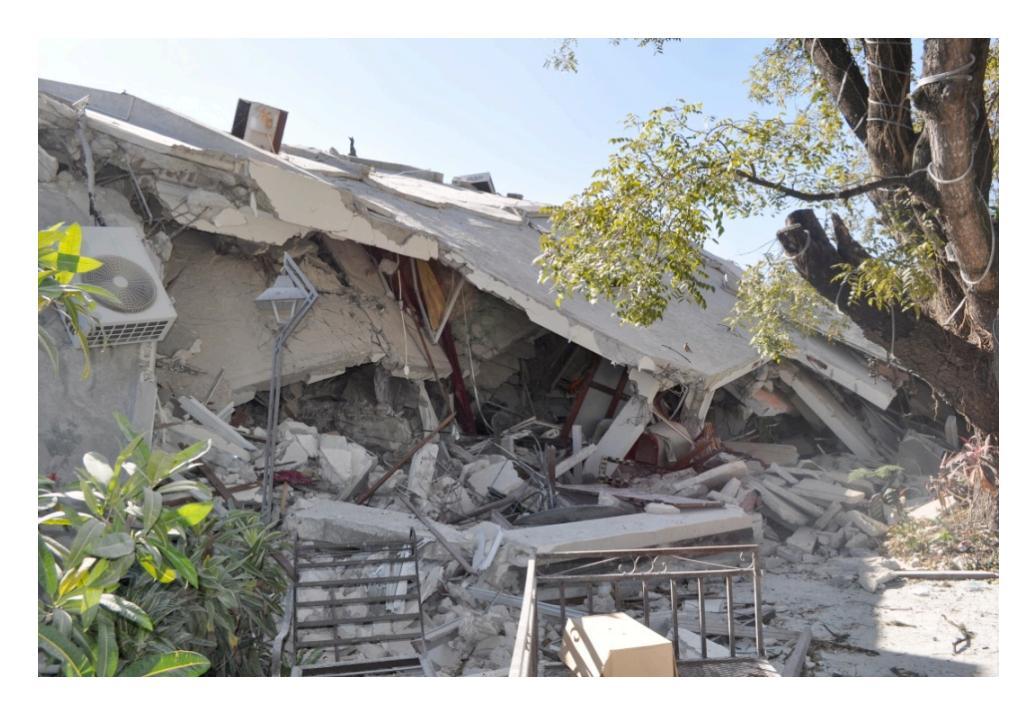
**Figure 19.** Collapse was extensive throughout the guest wings of the Hotel Montana. It appeared that these wings were constructed of reinforced concrete with unreinforced infill concrete masonry walls.

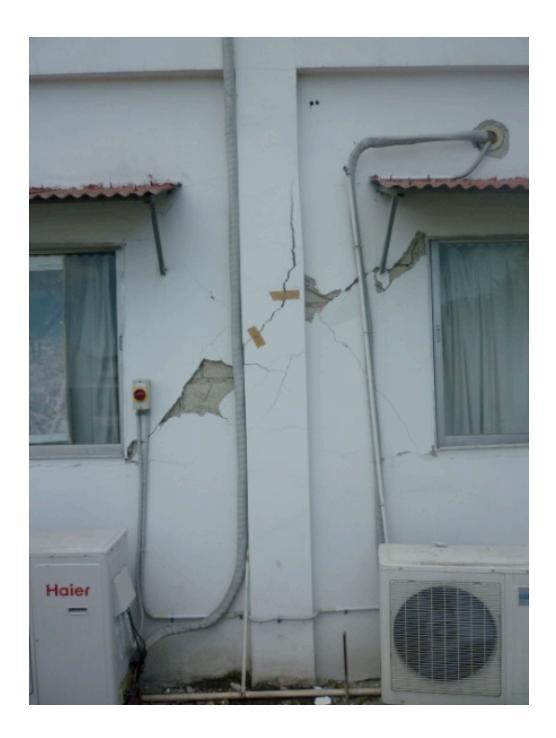
On the north side, the structure had diagonal cracks up to 6 mm (1/4 in.) wide across the walls and columns at the first floor between window penetrations on the north wall (fig. 22). The north face appeared to have a residual displacement of about 3 mm (1/8 in.) to the east. On the northwest side of the structure, one of the columns had a residual flexural crack (3 mm, 1/8 in.) at its base. Only minor cracking was observed on the east and west walls. The south wall, which was solid, showed minimal signs of damage. Similarly, the interior columns and walls showed little distress.

**Figure 22.** Exterior-wall cracking of the first floor of the CITS Building.

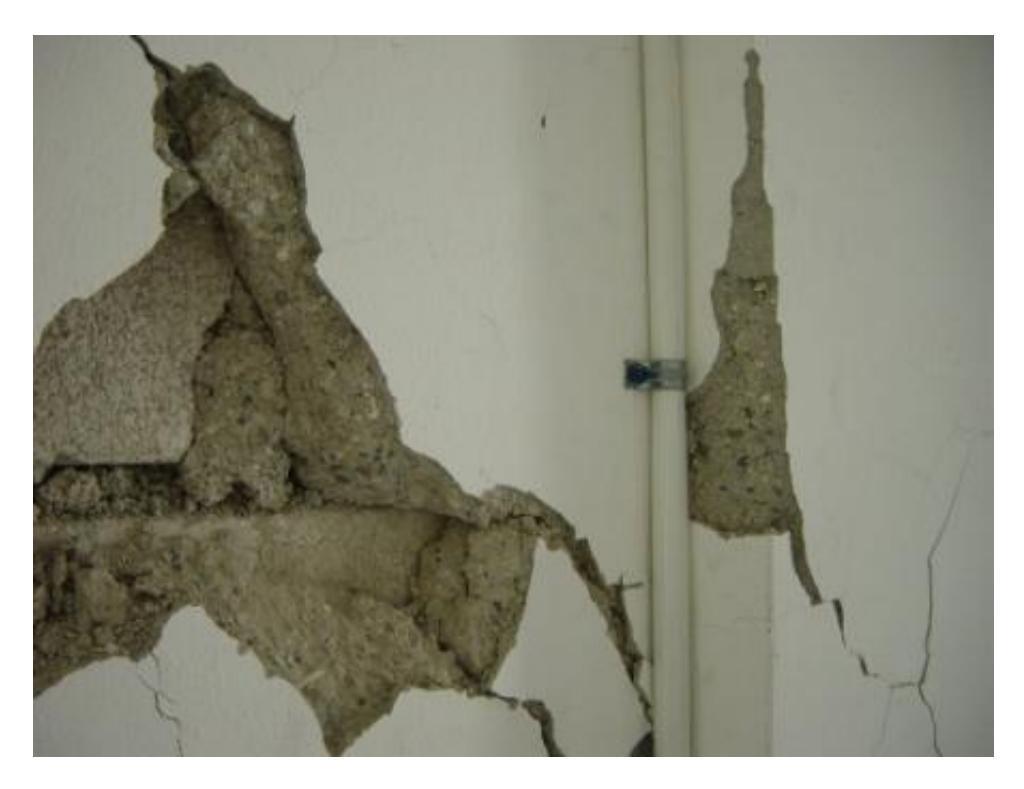
Figure 23. Interior close-up view of wall crack at the CITS Building.

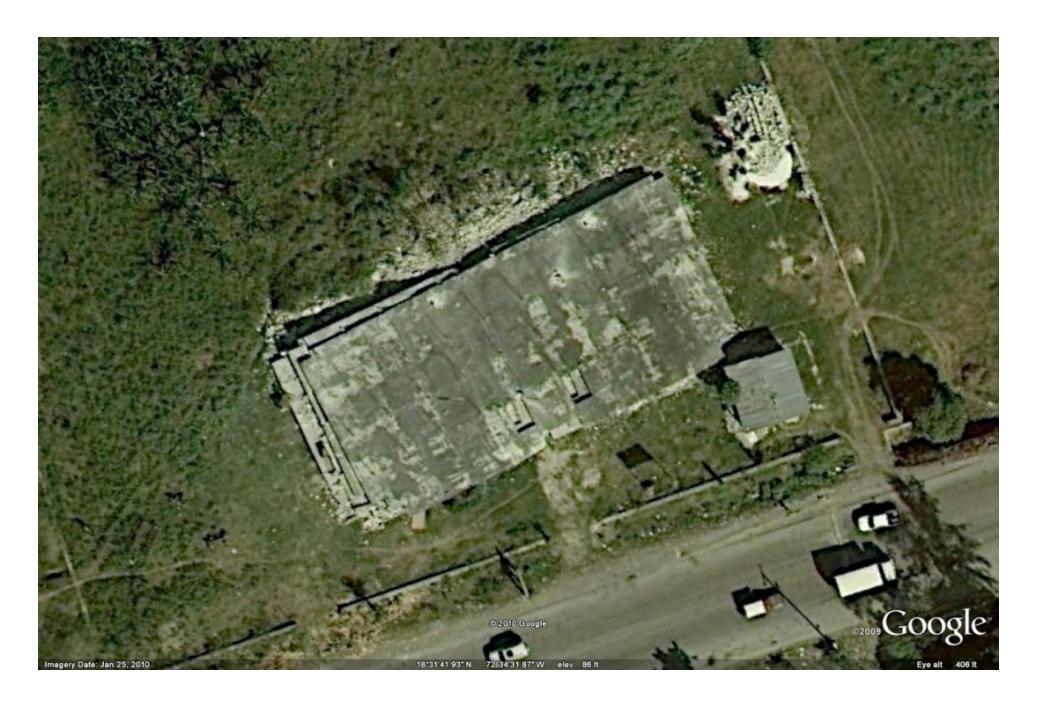
**Figure 24.** Aerial view indicating that the UNIH University Building under construction rotated slightly and moved to the east as it collapsed. (Google Earth)

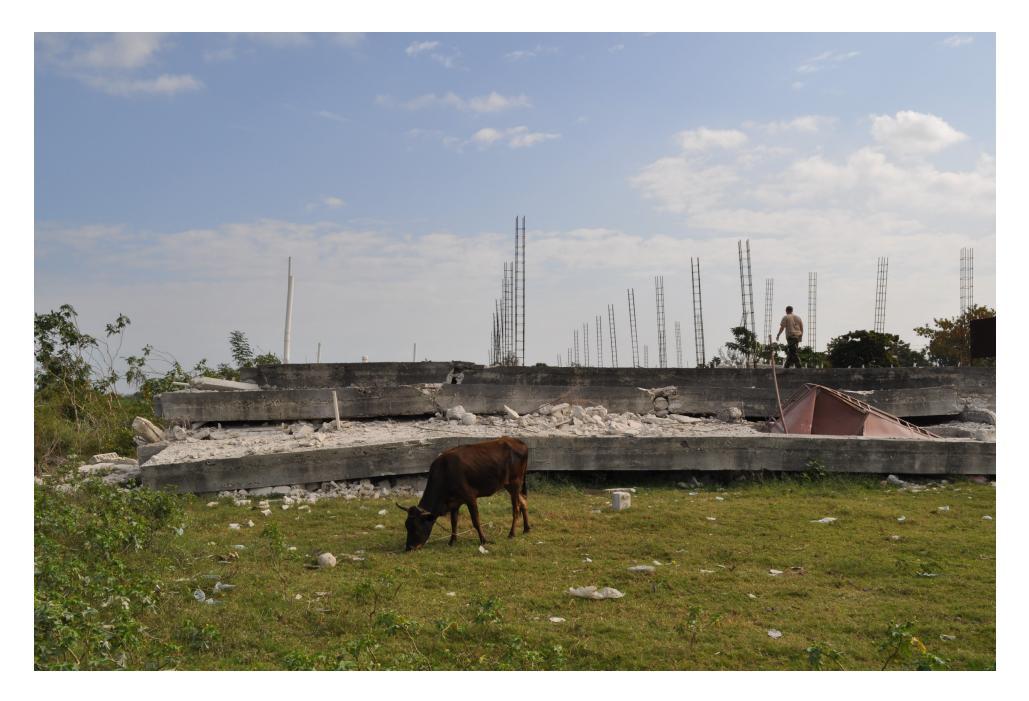
**Figure 25.** A view from the west side of the UNIH University Building under construction indicates that there was movement to the east (approximately half the height of the columns) during the collapse.

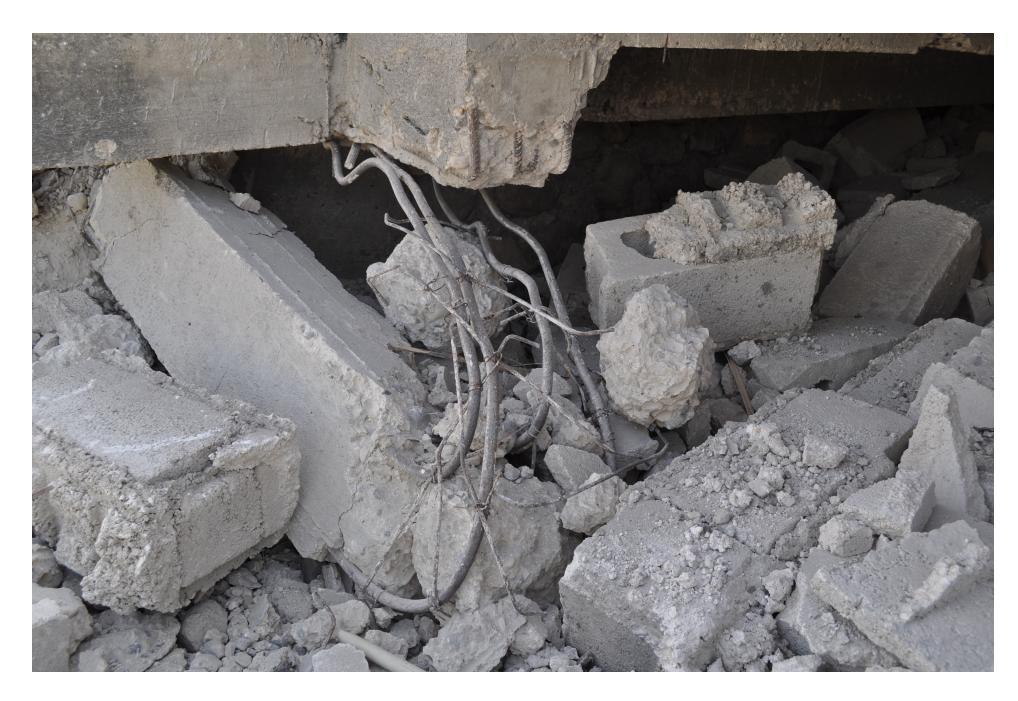
The reinforcing steel for both the columns and beams was minimal, with a combination of smooth and deformed reinforcement (figs. 26 and 27). The longitudinal reinforcement in the columns typically consisted of four #4 or #5 bars (fig. 26). The transverse column reinforcement appeared to consist of smooth #2 bars spaced at 200 to 230 mm (8 to 9 in.). The structure had little (if any) maso dnry in place at the time of the earthquake, but a stack of CMUs adjacent to the structure suggests that infill was to be added later. An ETABS model of the building (fig. 28) indicated that the structural frame would have been adequate for gravity loads but would have been highly overstressed for lateral seismic loads.

**Figure 26.** Smooth reinforcing steel and minimal column ties were evident in some of the collapsed columns at the UNIH University Building.

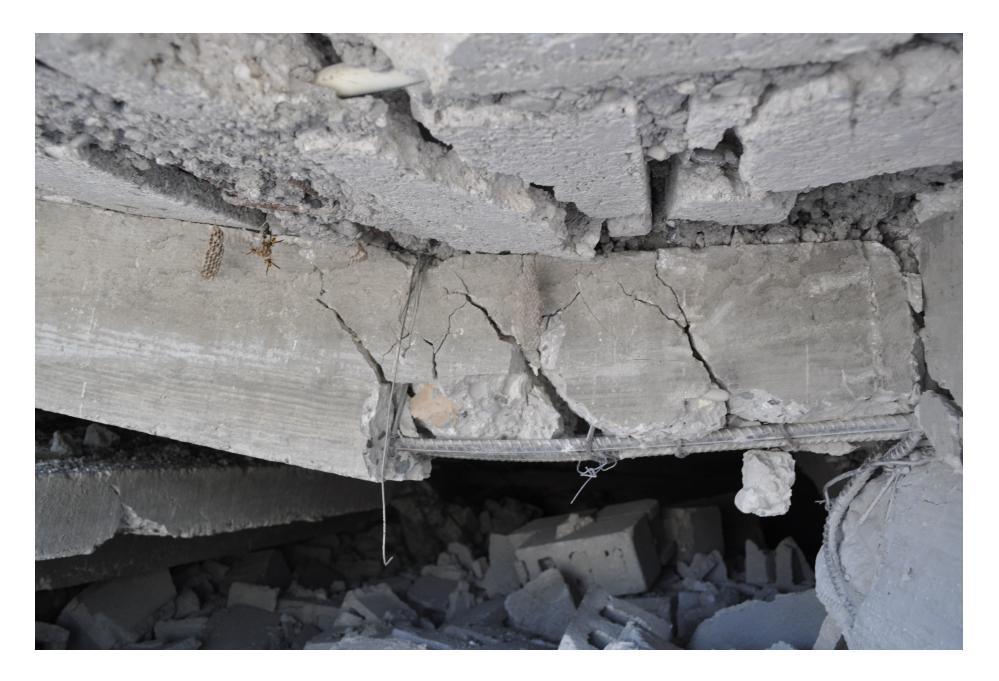
Figure 27. Failure in one of the structure's beams at the UNIH University Building.

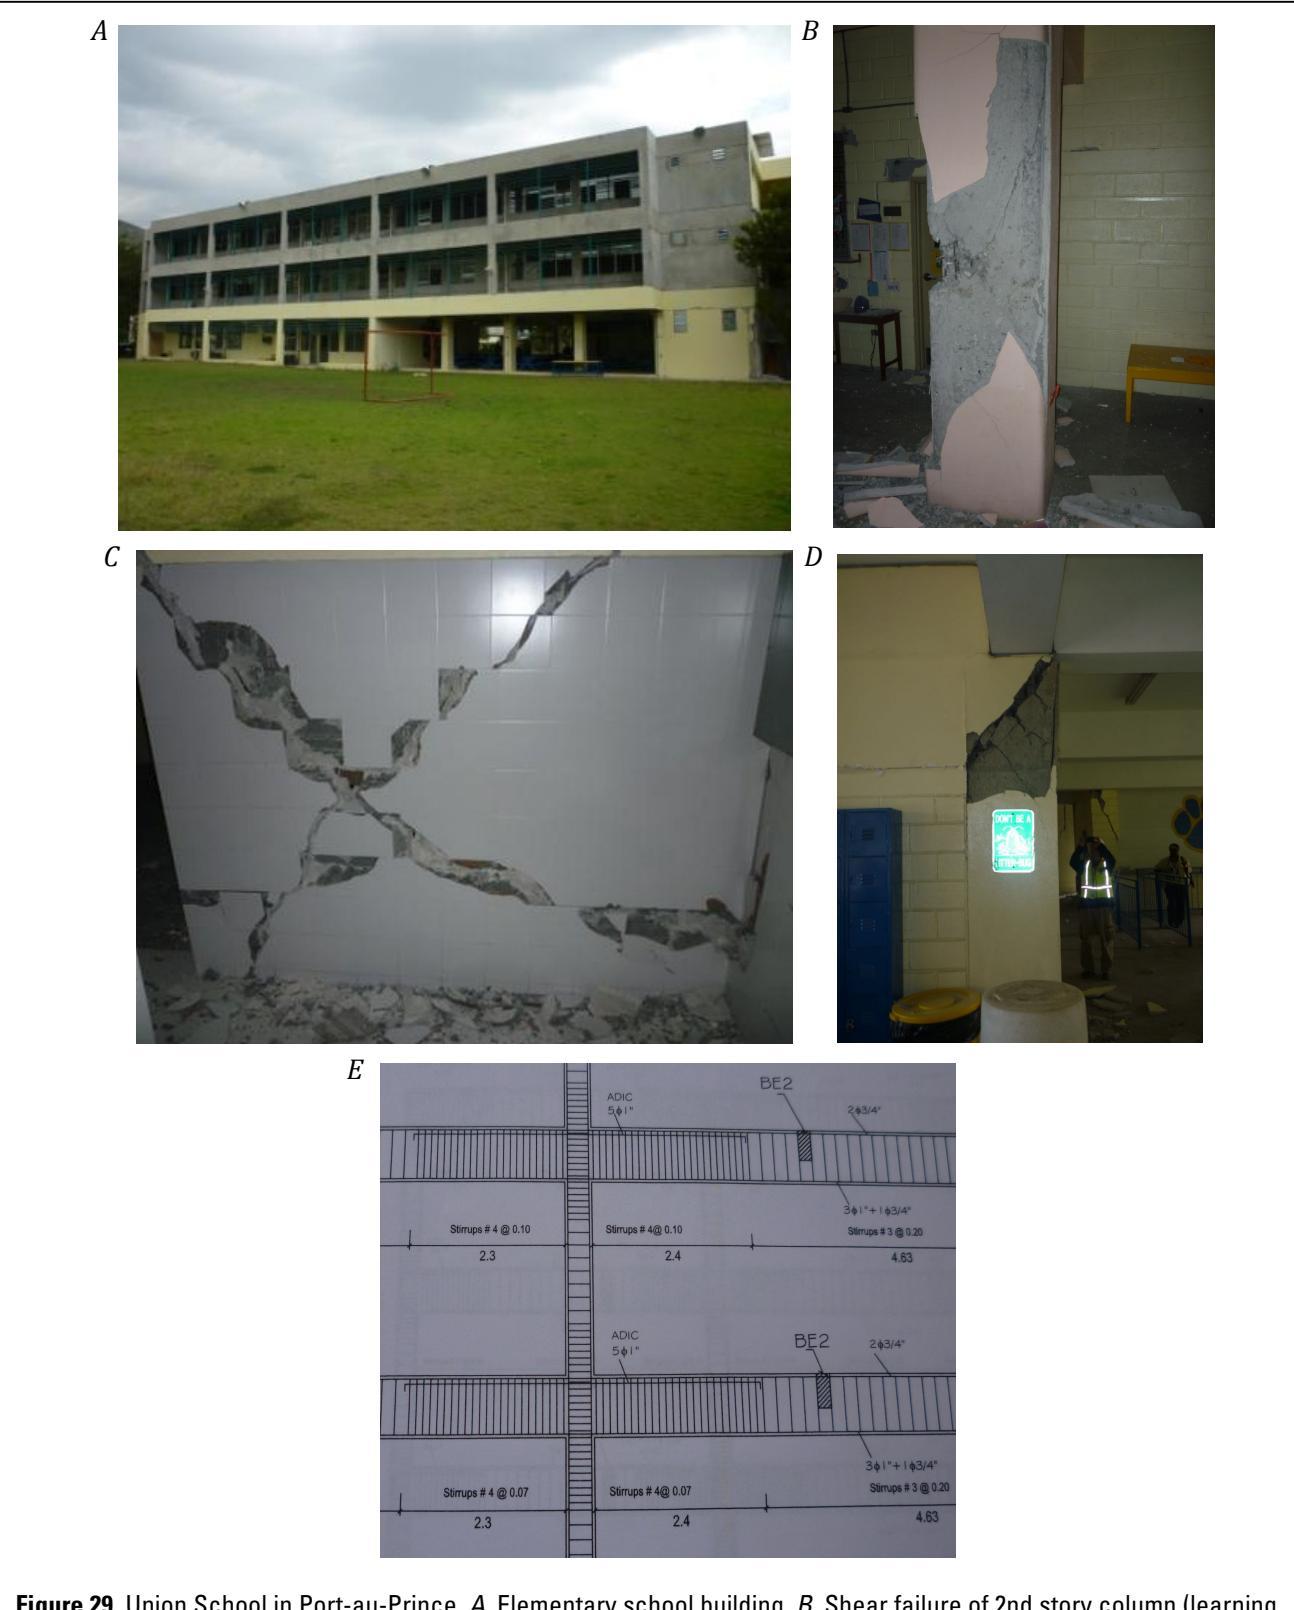
**Figure 29**. Union School in Port-au-Prince. *A*, Elementary school building. *B*, Shear failure of 2nd story column (learning center). *C*, Shear failure of masonry infill. *D*, 1st-story captive column (elementary school). *E*, Structural detail for second story column.

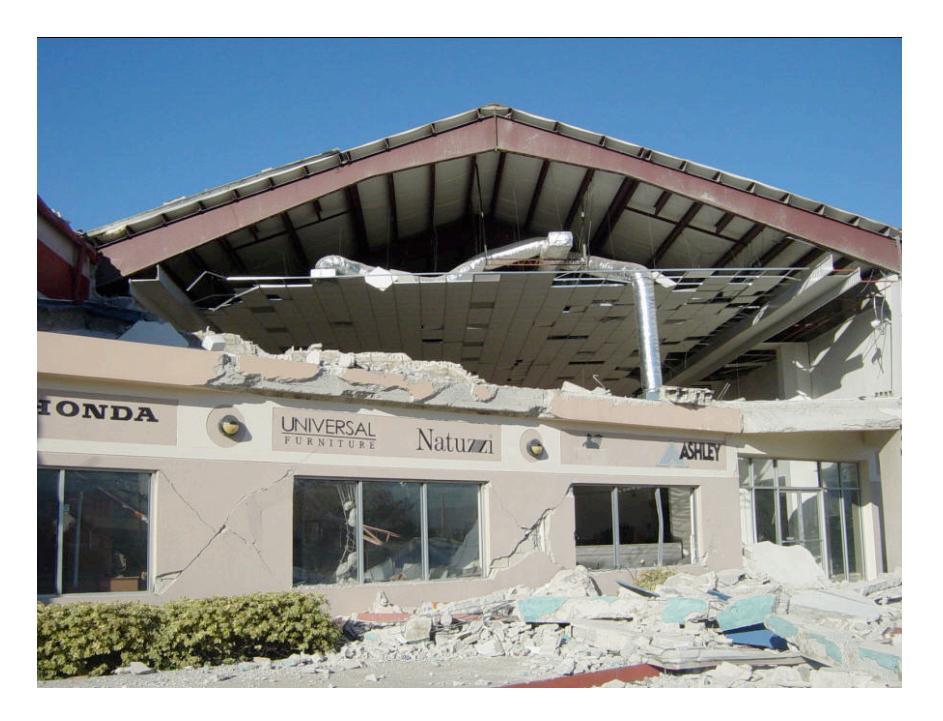
Figure 30. Infill masonry wall collapse of PEMB, Port-au-Prince.

- Figure 30 shows in-plane failure of the masonry infill. Even without the failure of the columns, the widespread failure of the masonry infill alone would have been costly and would have led to long interruptions to the function of the school.
- Figure 31 shows the out-of-plane failure of a warehouse masonry façade. This failure exposed the interior of the building to the elements, and because of the large amount of failed material, posed a hazard to people near the façade.
- Figure 32 shows one of the consequences of moving into new buildings to escape damage in other buildings. The heavy boxes are precariously positioned above one of the relocated workers from the CITS Building.

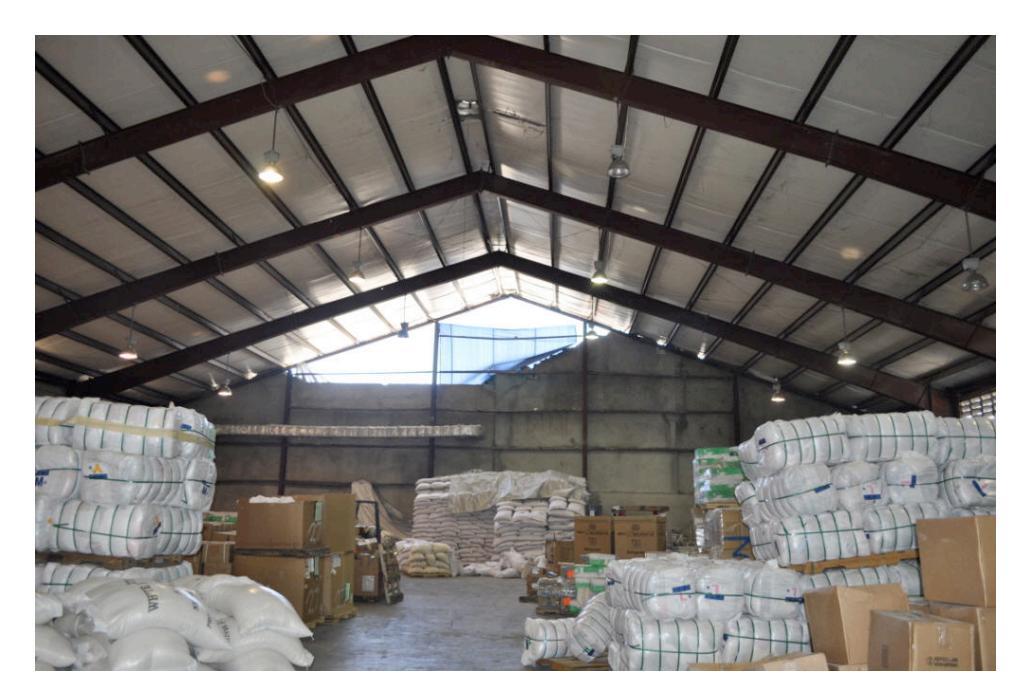
A negative aspect of the performance of the steel-framed structures was the detachment of the nonstructural masonry. The extent of the resulting damage varied. In one case, the failure of the masonry caused the roof below to collapse. Figures 30 and 31 show two typical examples of PEMB structures in Port-au-Prince in which the masonry failed out of plane. We saw no evidence of ties between the structural steel and the masonry walls.

Figure 31. Infill masonry wall collapse of PEMB, Port-au-Prince.

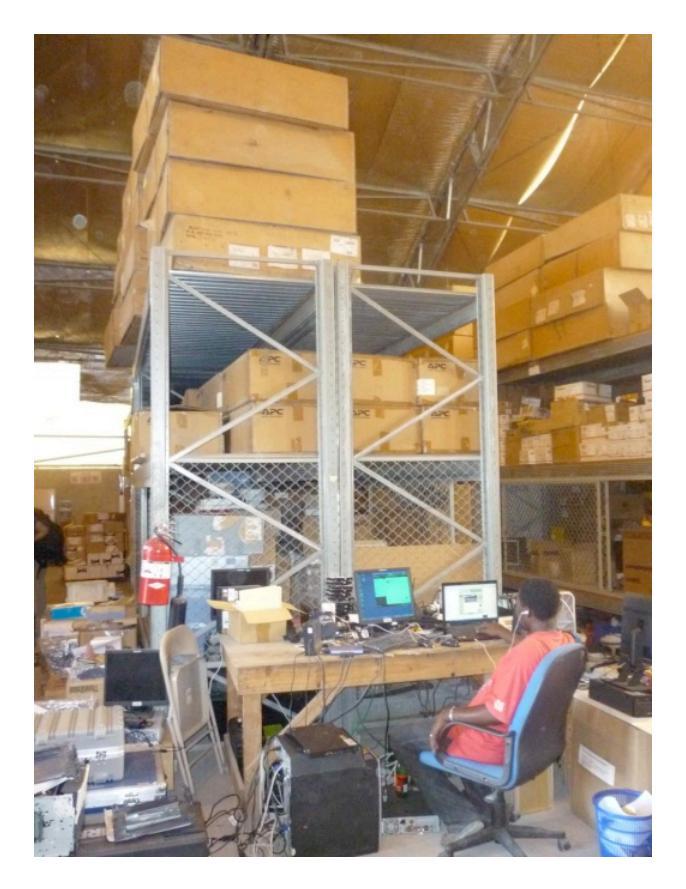
**Figure 32.** Heavy boxes are perched precariously above a worker who had been displaced by damage to the CITS building.

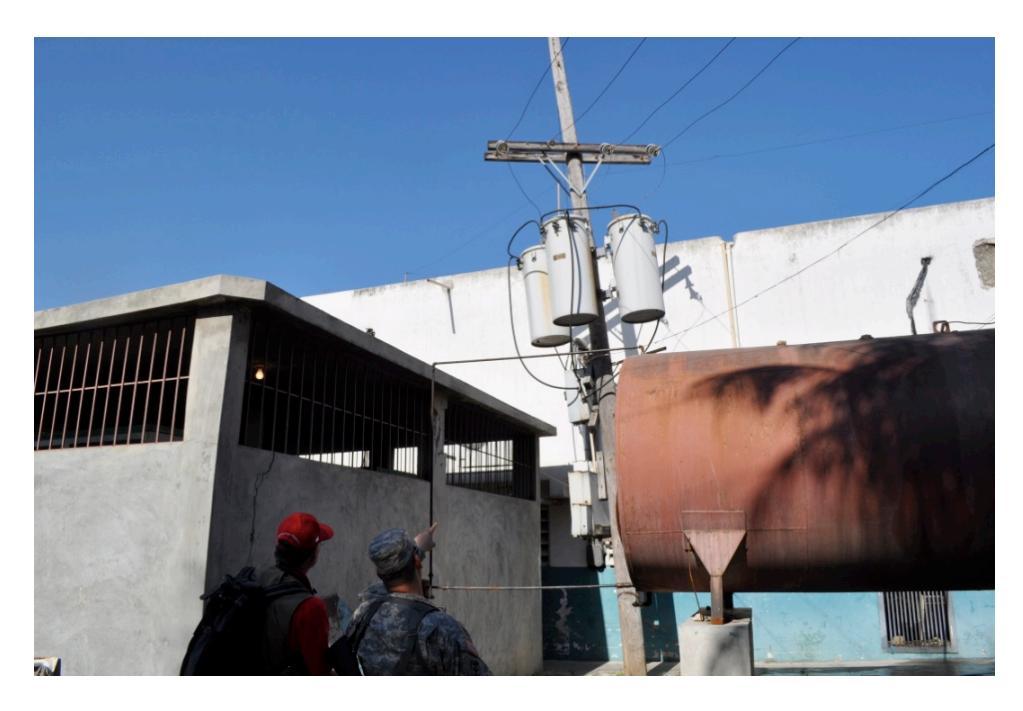
- As shown in figure 33, the power lines and transformers were located over and directly adjacent to the diesel fuel tank.
- The diesel fuel tank for the generators was not tied down to its supporting concrete foundation pedestals (fig. 34).
- The power pole with its heavy transformers moved during the earthquake and is now leaning. The extent of the residual movement is shown in figure 35.
- A nearby nonstructural wall is leaning towards occupied office space (fig. 36).

Figure 33. Hospital emergency power system, generator room and fuel tank.

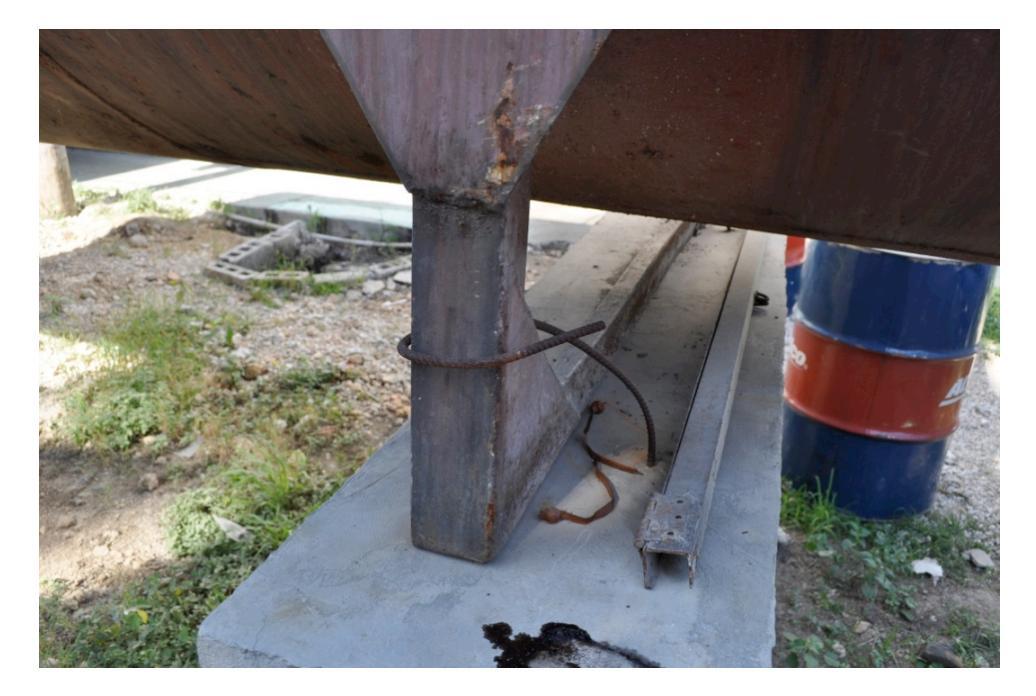
Figure 34. Fuel tank at hospital is not tied to its pedestal foundation.

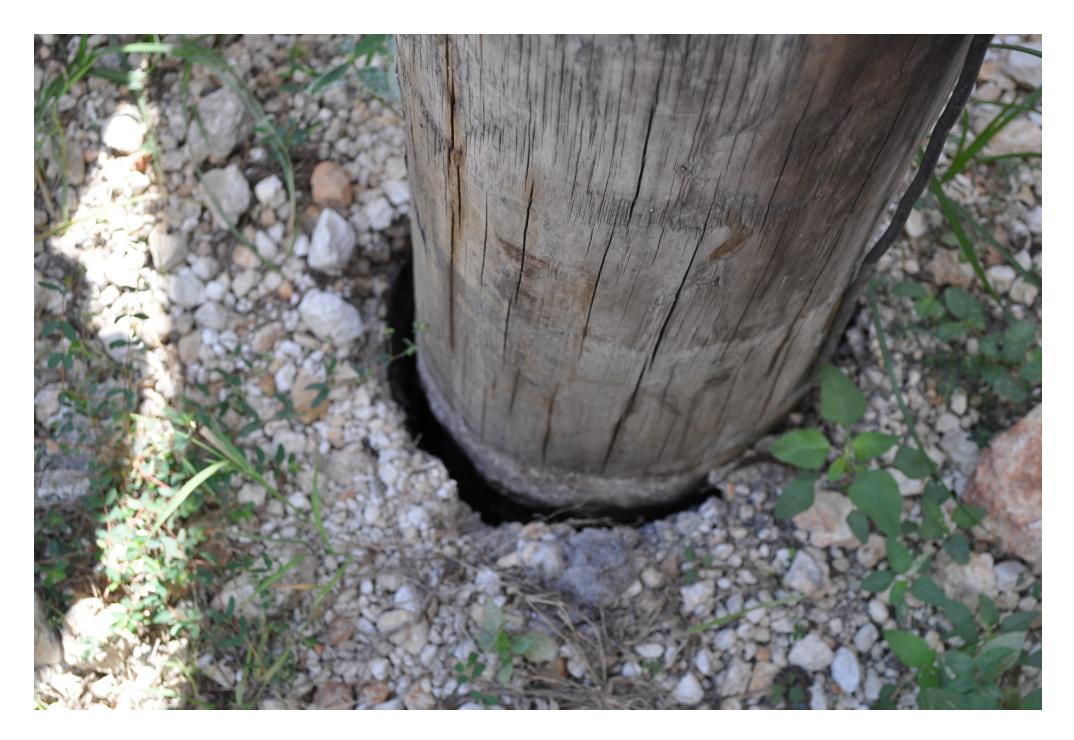
**Figure 35.** Base of power pole at hospital indicates some of the movement that occurred during the earthquake.

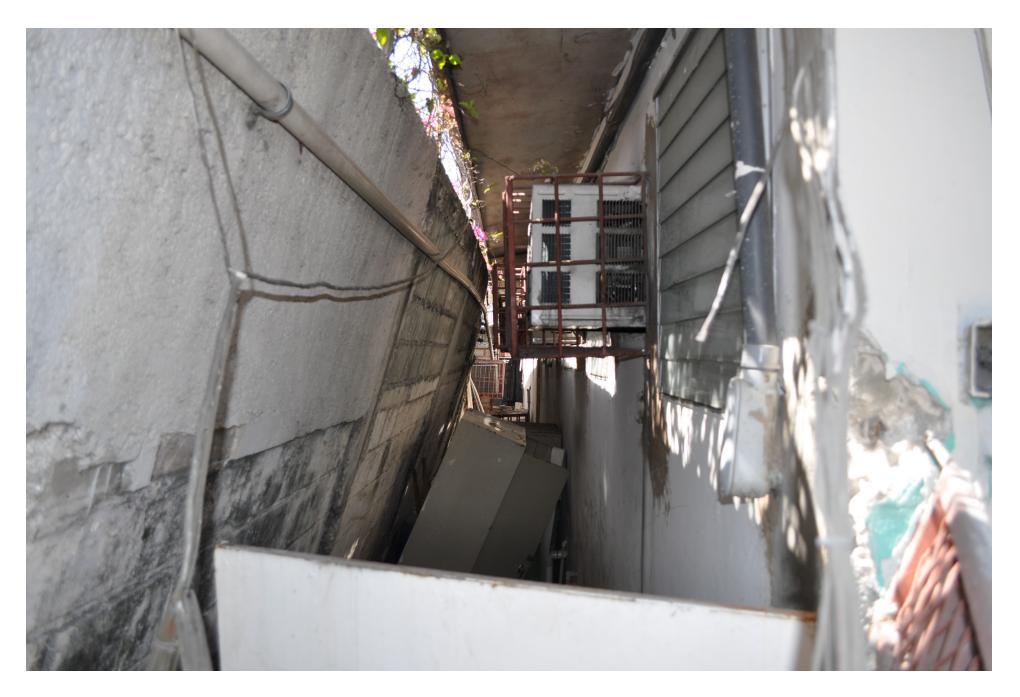
**Figure 36.** As with many masonry walls, the earthquake caused this one at the hopsital to lean. In this case, the wall is leaning towards occupied office space.
