# The *M<sub>W</sub>* 7.0 Haiti Earthquake of January 12, 2010: USGS/EERI Advance Reconnaissance Team Report

By Marc O. Eberhard, Steven Baldridge, Justin Marshall, Walter Mooney, and Glenn J. Rix

Open-File Report 2010-1048

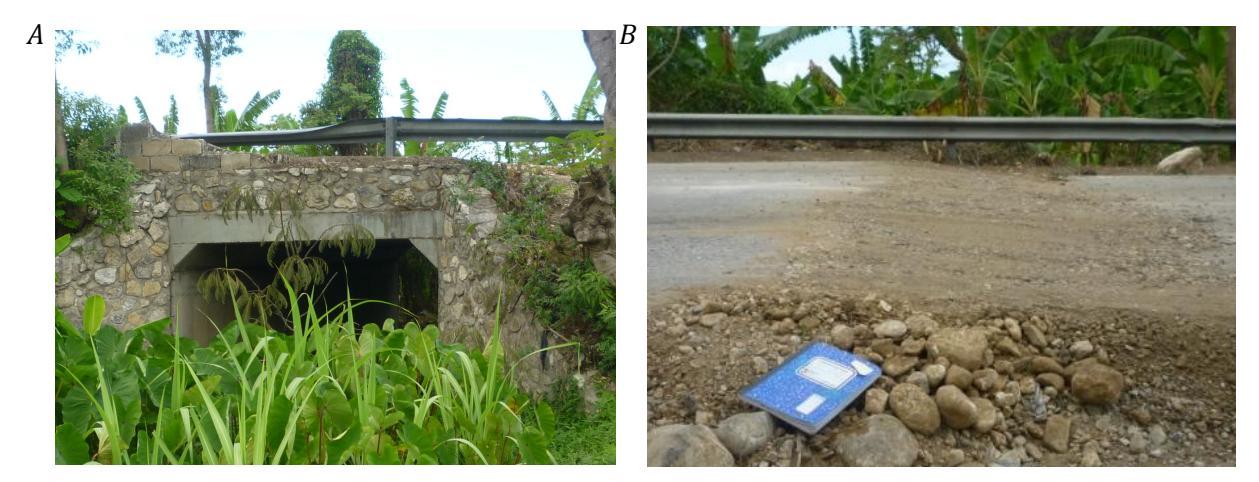
Figure 40. Settlement of approach to culvert. A, Elevation. B, Close-up of step.

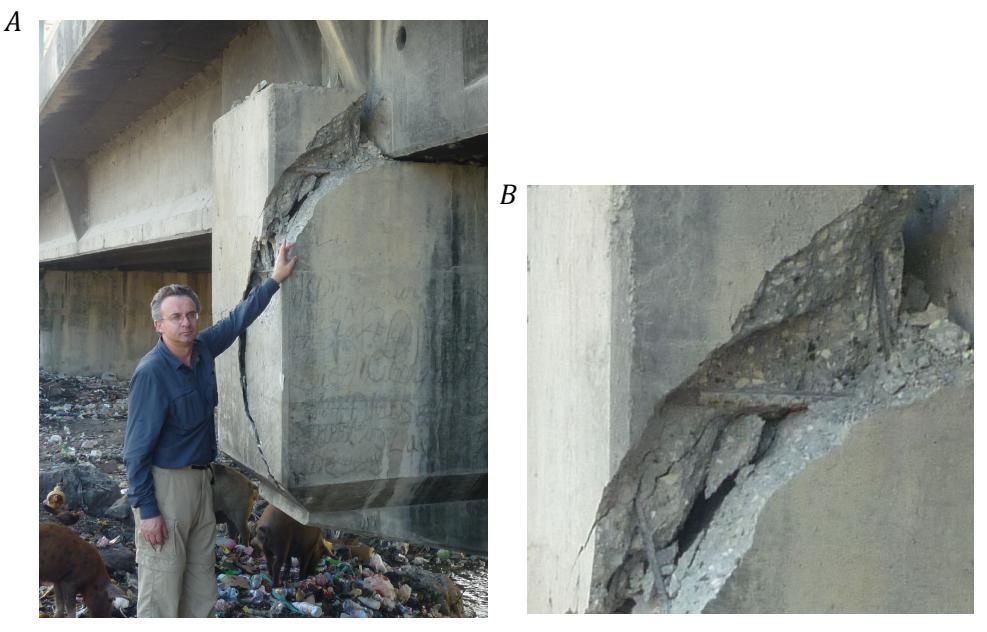
**Figure 41.** Damage to shear key at intermediate support of bridge. *A*, Overview. *B*, Pull-out of beam reinforcement.

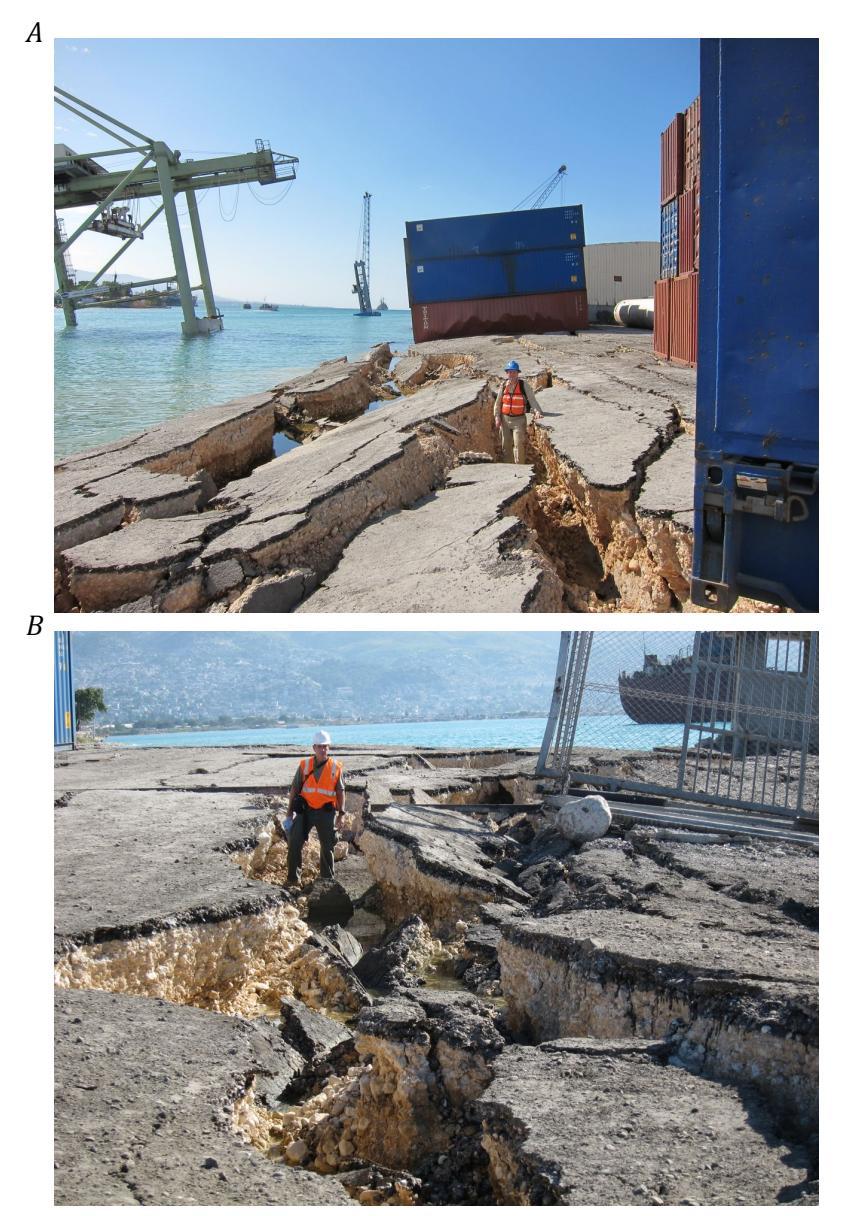
Figure 43. Fissures caused by lateral spreading at (A) eastern and (B) western ends of the North Wharf.

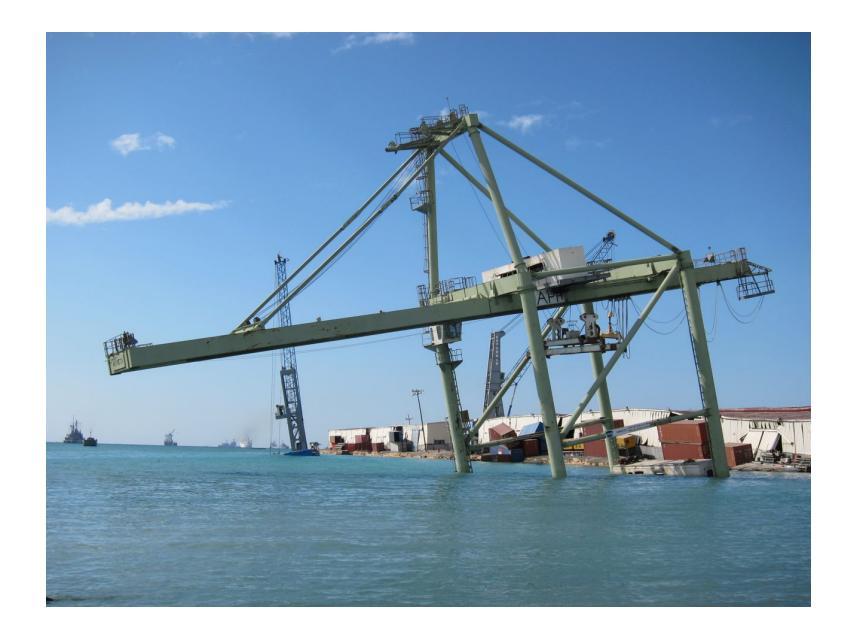
**Figure 44.** Submerged 15 m gauge container crane (foreground) and mobile crane (background).

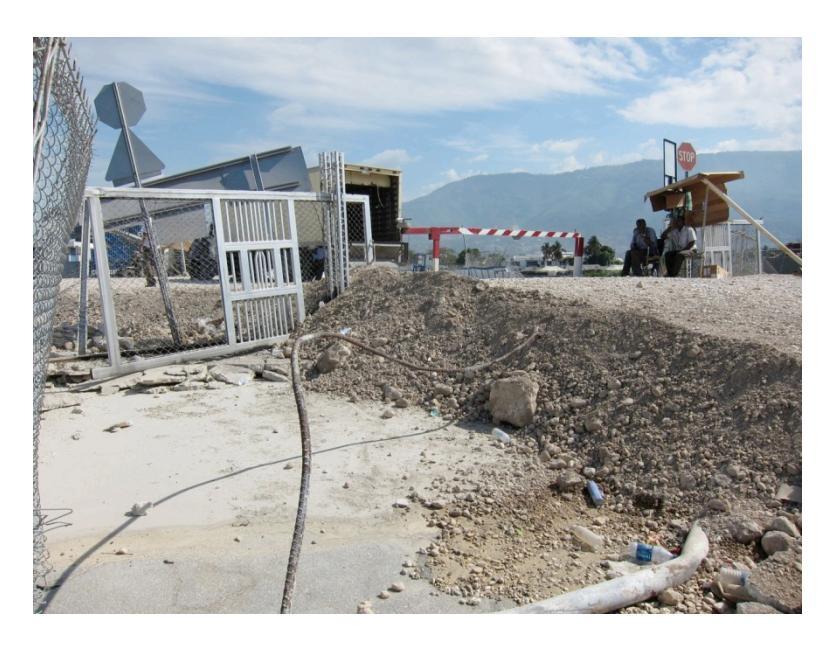
**Figure 46.** Approximately 1 m (3.3 ft) of fill was required to level the approach to the South Pier of the port.

re-level the approach to the pier, as shown in figure 46.

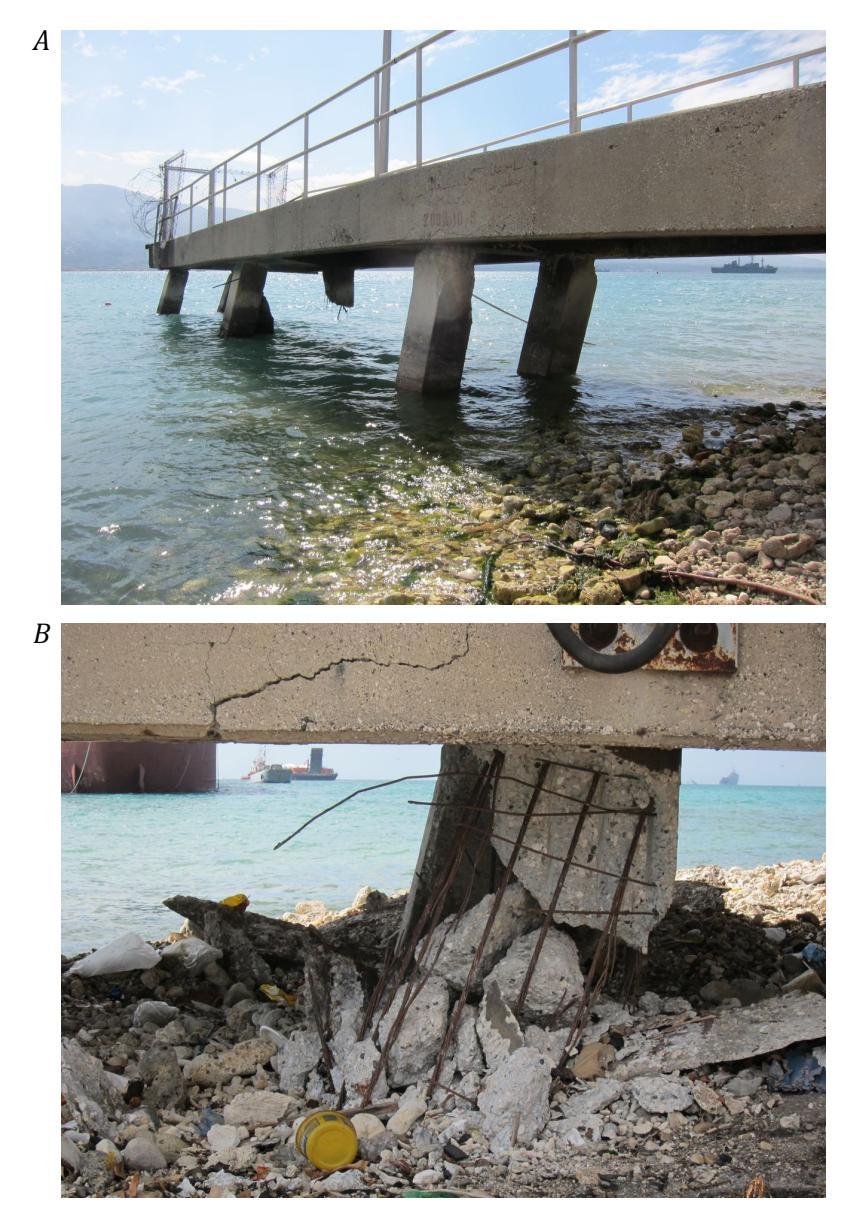
**Figure 47.** Damage at the port. *A*, Damage to piles supporting the pedestrian bridge connecting the South Pier to the island. *B*, Extensive damage to the landward row of piles.

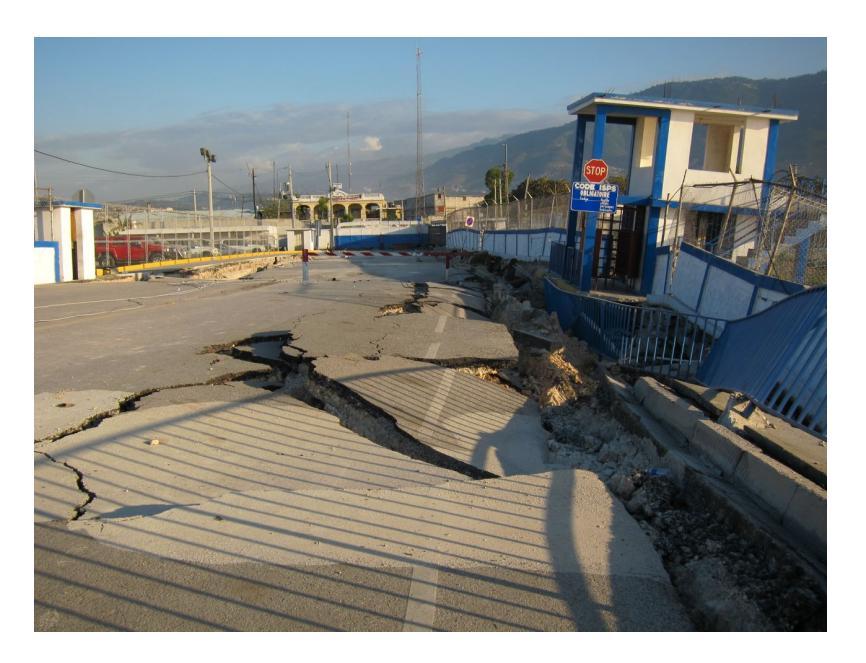
Figure 48. Damage to entrance road caused by lateral spreading.

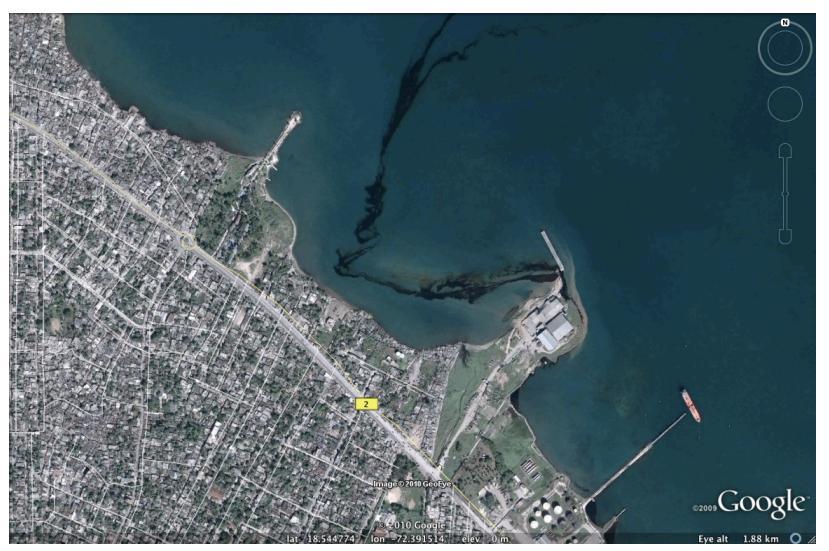
**Figure 50.** Satellite image of the Thor marine oil terminal on January 13, 2010, showing a small oil spill (Google Earth).

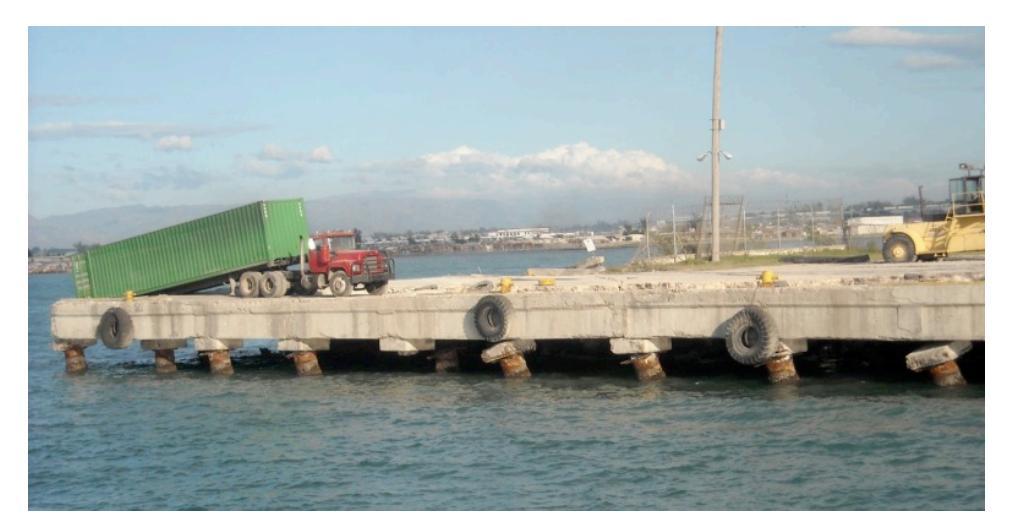
**Figure 51.** Remaining portion of pile-supported pier at the Varreux terminal (Source: Scott Chodkiewicz, U.S. Army Corps of Engineers).

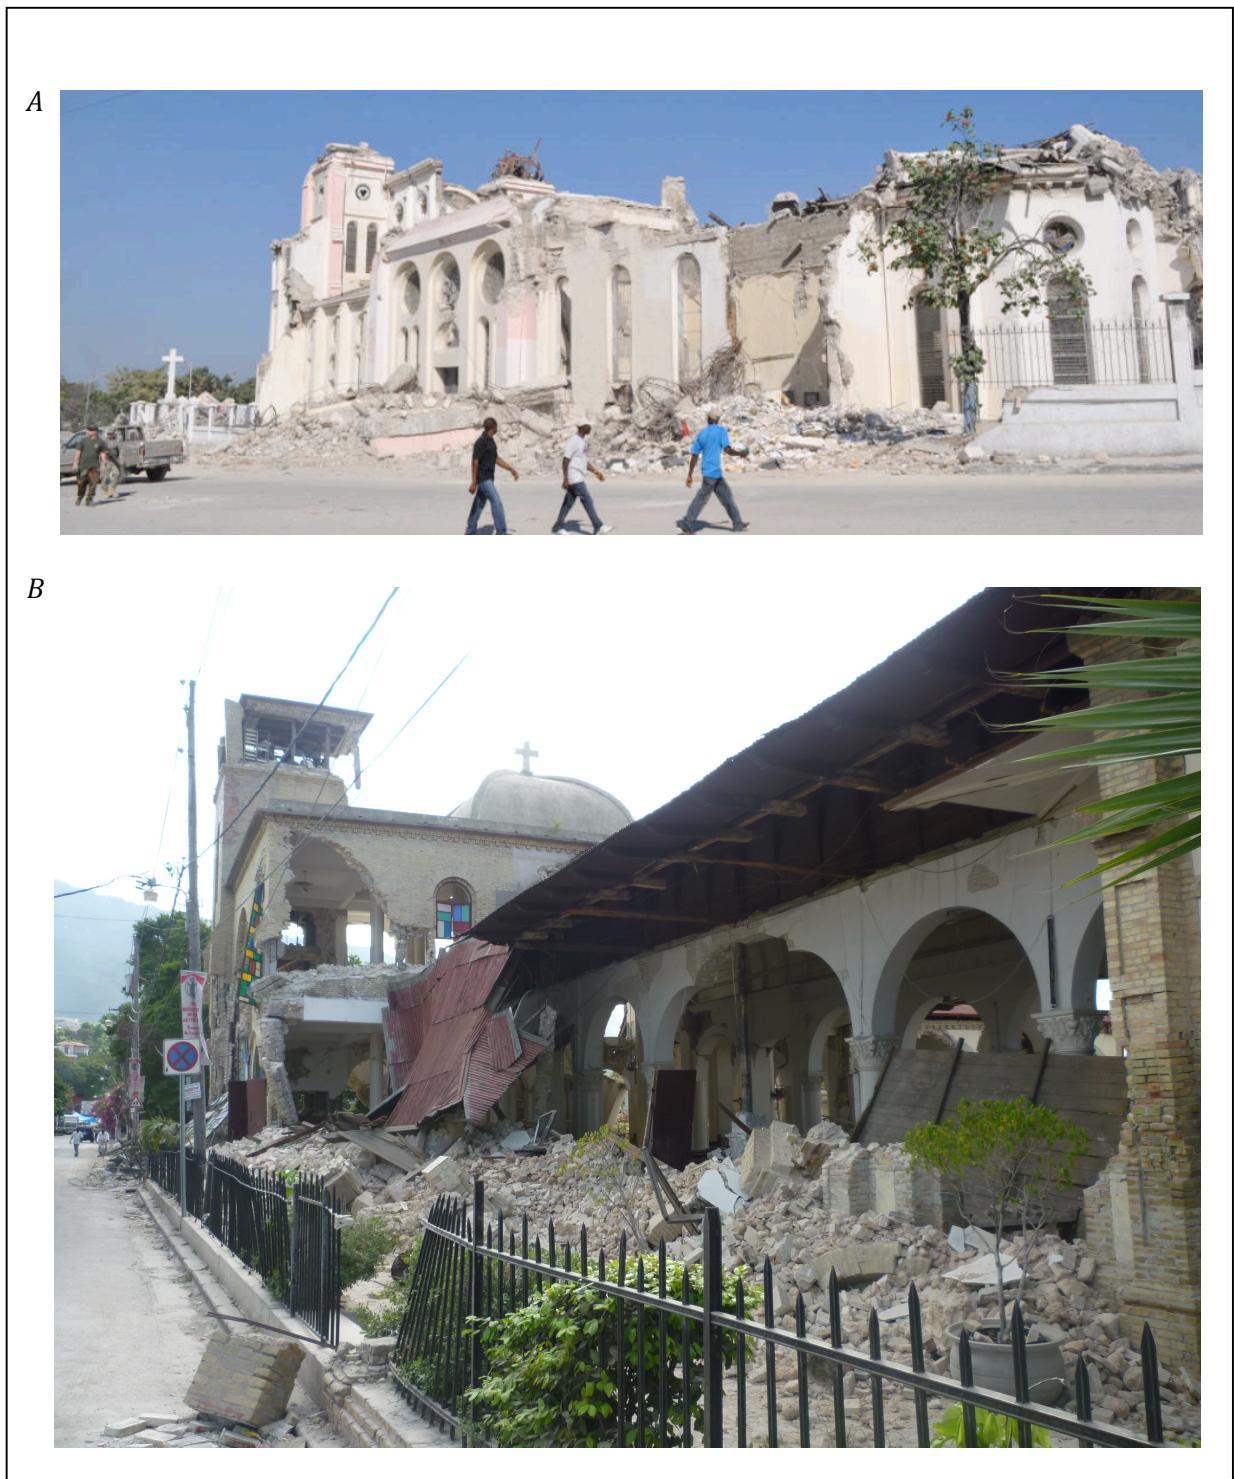
Figure 53. Damage to religious structures in Port-au-Prince. A, Grand Cathedral. B, Church of the Sacred Heart.
