# The 17 July 2006 Tsunami Earthquake in West Java, Indonesia

A tsunami earthquake  $(M_w=7.7)$  occurred south of Java on 17 July 2006. The event produced relatively low levels of high-frequency radiation, and local felt reports indicated only weak shaking in Java. There was no ground motion damage from the earthquake, but there was extensive damage and loss of life from the tsunami along 250 km of the southern coasts of West Java and Central Java. An inspection of the area a few days after the earthquake showed extensive damage to wooden and unreinforced masonry buildings that were located within several hundred meters of the coast. Since there was no tsunami warning system in place, efforts to escape the large waves depended on how people reacted to the earthquake shaking, which was only weakly felt in the coastal areas. This experience emphasizes the need for adequate tsunami warning systems for the Indian Ocean region.

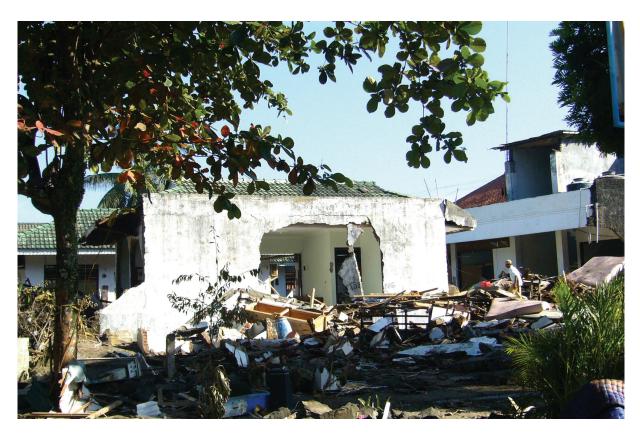
▲ Figure 4(A). Tsunami damage to unreinforced masonry buildings and debris in Pangandaran.

Three days after the earthquake, we were in the region of the tsunami to inspect the damage. We visited several sites along the south coast of Java from Pangandaran west to Marsawah village. The largest loss of life was in the resort area of Pangandaran, where more than 200 people were killed. Numerous woodenstructure cafes and shops within 20 m of the waterfront were all washed away by the tsunami. If the tsunami had occurred one or two days earlier on the weekend, there probably would have been many more deaths on the crowded beaches. There was severe damage to almost all structures within several hundred meters of the waterfront, where the construction was predominantly one- and two-story buildings of unreinforced clay-brick masonry. Some of the larger hotels appeared to have better construction and suffered less structural damage. Damage consisted of collapsed walls, walls with large holes (especially where windows and doorway once existed), and large piles of debris consisting of building material and small boats (figures 4A and B). Damage extended several hundred meters from the shore. At two other villages, Batu Hiu and Batu Karas, located 13 and 18 km west of Pangandaran, respectively, there was similar tsunami damage to buildings.

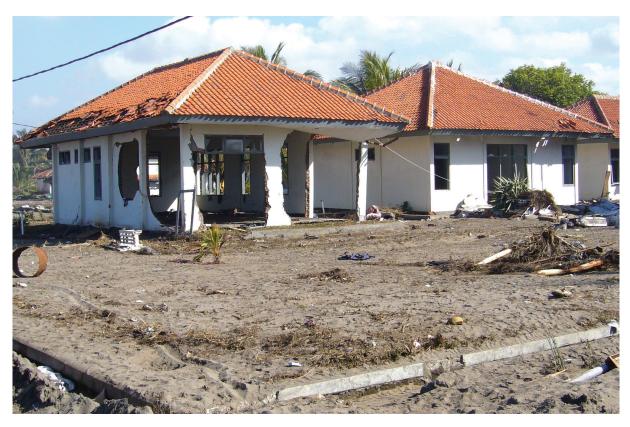
▲ Figure 4(B). Damage to buildings near Pangandaran. Note the damaged roof on the building on the left, which indicates the height of the tsunami.

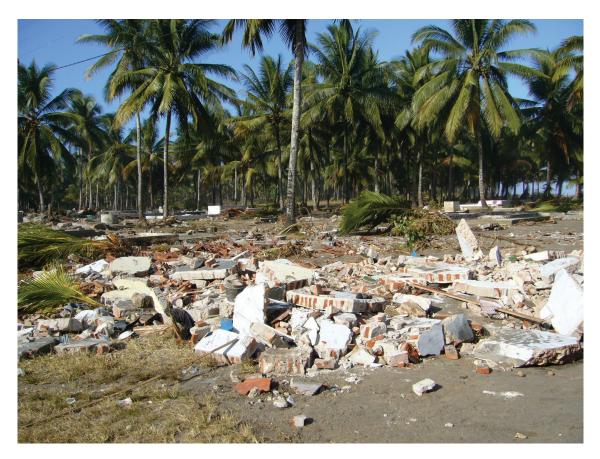
▲ Figure 5. Severe damage in Marsawah village, where no walls were left standing within about 150 m of the shore.

The most severe damage we saw was in Marsawah village, Bulakbenda, located about 22 km southwest of Pangandaran. Within about 150 m of the coast, all of the buildings were completely washed away; there were no walls standing and only the floors and foundations remained (figure 5). The buildings were one- and two-story residences of clay-brick masonry construction. Further inland, at distances of 300 to 500 m, many of the buildings were also completely destroyed. Eyewitness accounts report that the tsunami had heights of 6 to 8 m. It was reported that waves broke about 200 to 300 m inland from the shore and came down vertically on top of the houses in this region.
