Overview of the 2010 Haiti Earthquake

Reginald DesRoches,^{a)} M.EERI, Mary Comerio,^{b)} M.EERI,
Marc Eberhard,^{c)} M.EERI, Walter Mooney,^{d)} M.EERI,
and Glenn J. Rix,^{a)} M.EERI

The 12 January 2010 M_w 7.0 earthquake in the Republic of Haiti caused an estimated 300,000 deaths, displaced more than a million people, and damaged nearly half of all structures in the epicentral area. We provide an overview of the historical, seismological, geotechnical, structural, lifeline-related, and socio-economic factors that contributed to the catastrophe. We also describe some of the many challenges that must be overcome to enable Haiti to recover from this event. Detailed analyses of these issues are presented in other papers in this volume. [DOI: 10.1193/1.3630129]

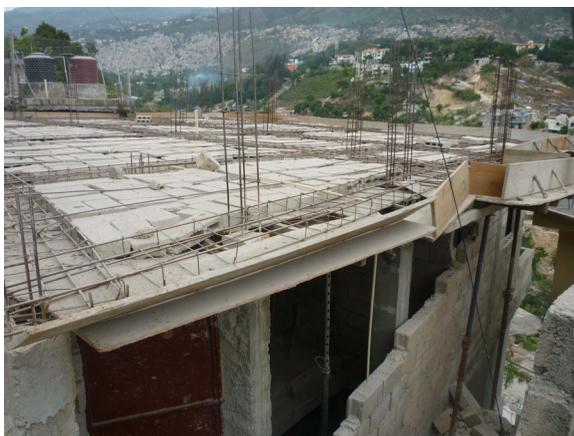
Figure 5. Residential concrete block slab construction.

Typical reinforced concrete frame buildings with concrete block infill had numerous vulnerabilities known to cause seismic damage. Figure 5 shows a typical low-rise reinforced concrete frame building with infill concrete block walls that was under construction at the time of the earthquake. Columns were slender with depths in the range of 200 mm to 250 mm. Such columns were often reinforced with 4 #4 bars, sometimes deformed and sometimes smooth. Column and joint transverse reinforcement was minimal (e.g., #2 smooth ties) and spaced at a distance roughly equal to the column depth. Concrete and mortar

quality appeared to vary significantly. In the building shown Figure 5, concrete blocks were placed outside the frame lines. More typically, the concrete block walls were used as infill. In some structures, column steel splices were placed directly above the elevation of the floors.

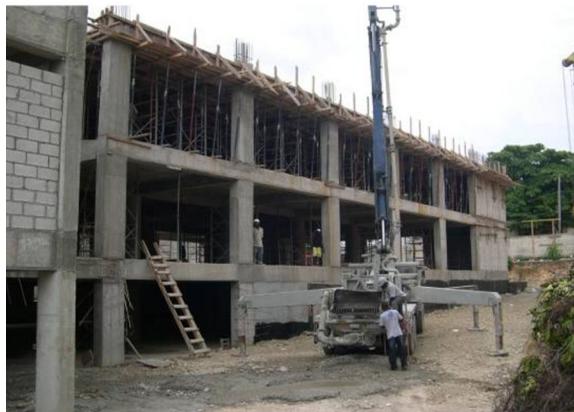
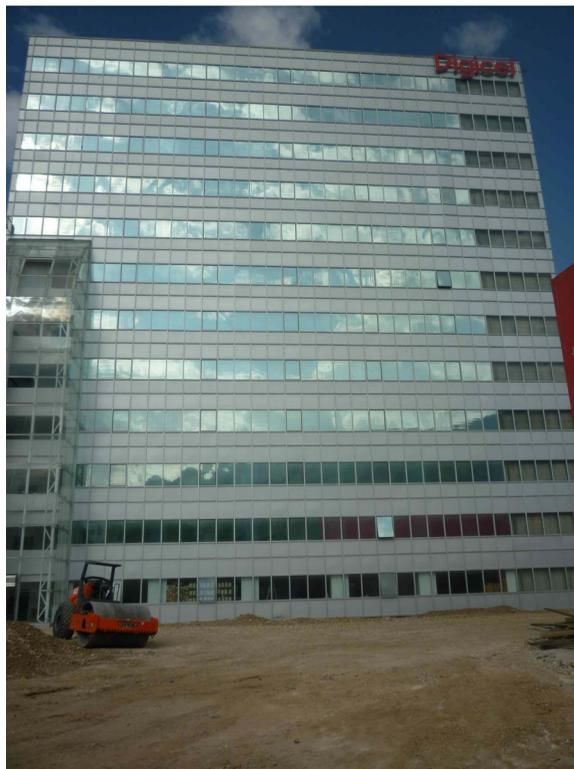
Figure 7. Damage to two structures across the street from one another in Port-au-Prince: (a) Reinforced concrete frame with masonry infill, and (b) new Digicel building under construction appears to be nearly undamaged.

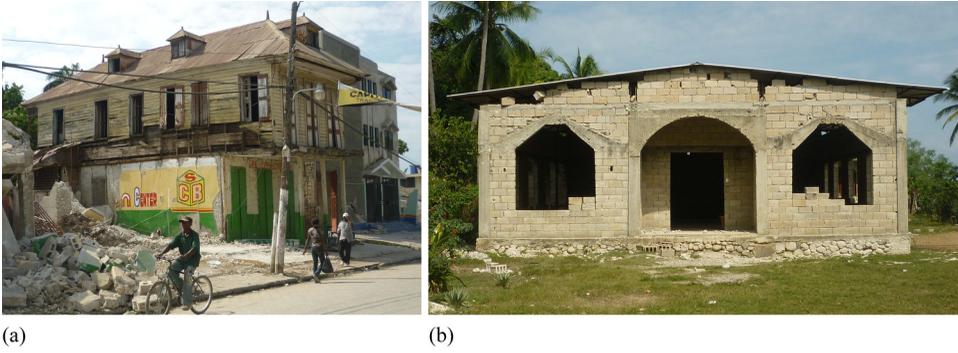
Figure 8. Light buildings that were damaged but did not collapse: (a) Wood-frame building, and (b) church with masonry walls and light-metal roof.

It appears that some buildings performed better than their neighbors because of their low mass. For example, the wood-frame building shown in Figure 8a was adjacent to a collapsed reinforced concrete structure. Similarly, the one-story church shown in Figure 8b had a light-metal roof supported by masonry walls. Although it appeared to be constructed with materials of poorer quality than those used in a neighboring concrete bearing-wall house, the masonry church structure suffered less damage.

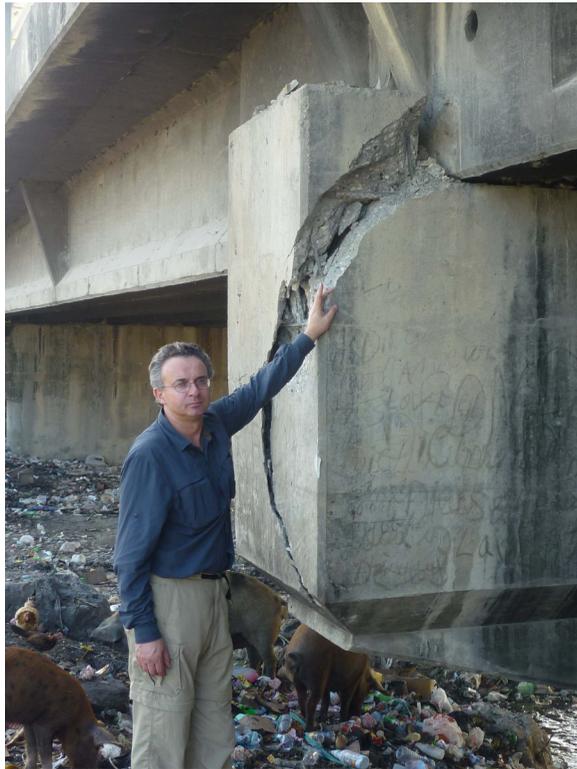
Figure 9. Damage to shear key at intermediate support.

The main river crossings on Nationale No. 2 were spanned by bridges with precast girders resting on cast-in-place reinforced concrete bents and supporting a cast-in-place deck. We observed damage to two such bridges. The bridge over the Momance River had minor pounding damage at one of the intermediate supports. In the Carrefour section of Port-au-Prince the external shear keys (Figure 9) of a similar bridge were damaged at both intermediate supports. This failure was apparently caused by the lack of hook anchorage at the end of the top beam reinforcement.

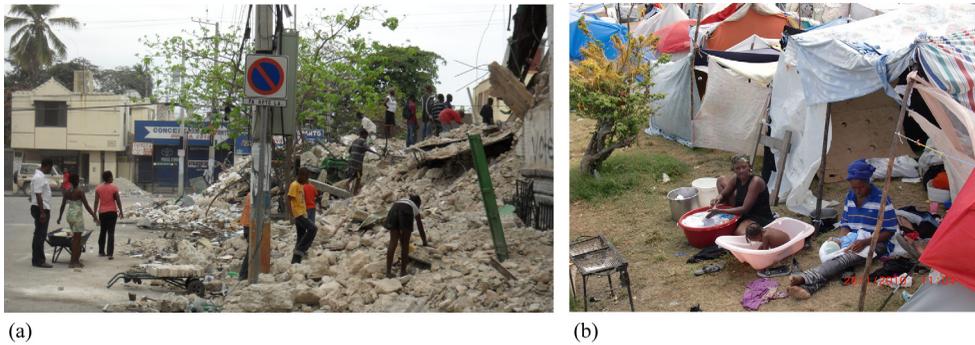
Figure 10. (a) Salvaging materials from damaged buildings, and (b) tent camps created by earthquake victims.

Tents and tarps were provided by a variety of international groups, but many Haitians formed informal tent camps with materials salvaged from the rubble, as shown in Figure 10. Of the 1.3 million homeless, UN Habitat and USAID estimated that over 500,000 left Port-
