Learning from Earthquakes

The M_w 7.6 Western Sumatra Earthquake of September 30, 2009

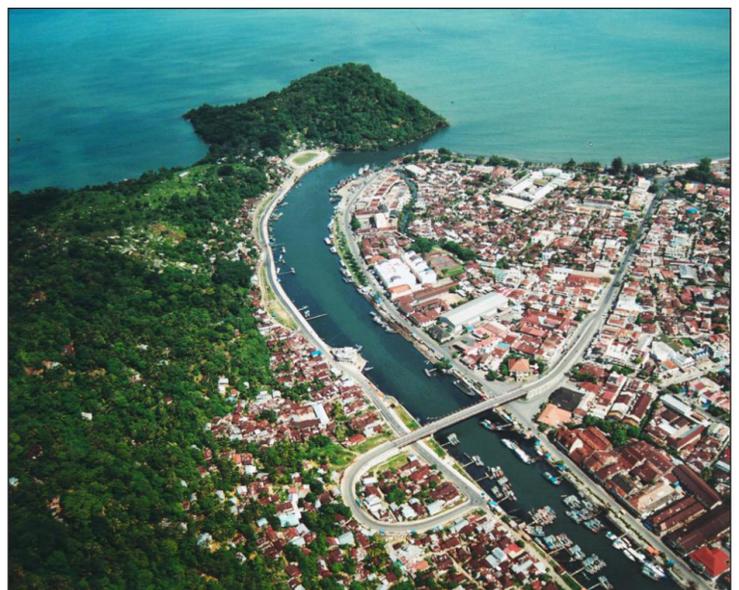
Figure 2. Padang and the Batang Arau River viewed from the mountains to the east.

Preliminary information from soil borings in Padang shows the subsurface consisting of medium dense to dense silty sand and stiff to very stiff silt with relatively low ground water levels. In areas next to the Batang Arau River (Figure 2), the site conditions include undocumented fills consisting of loose, saturated fine sand, which were placed as part of the site development.

The Siti Nurbaya bridge (in Figure 2) is one of the few bridges outside of the mountain areas that suffered earthquake damage. It is an important link between the low-lying old town of Padang and high ground located to the south, and the bridge approach had ground cracking due to settlement and dynamic densification of fills within the reinforced earth ramp (Figure 4).

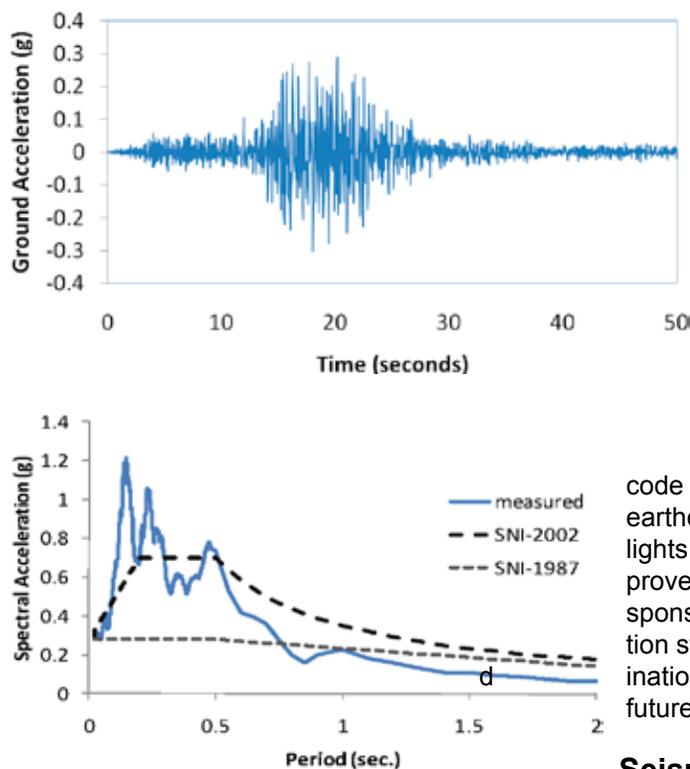
Figure 3. Ground acceleration and response spectra (N-S component) and design earthquake spectra (BMKG/USGS, 2009).

There is only one strong ground motion record from the region (BMKG/USGS 2009), which shows about 20 seconds of strong shaking with a peak ground acceleration (PGA) of 0.3g (Figure 3). The spectral accelerations in the short period ranged from 0.5g-1.2g and dropped off at longer periods. Since the instrument site was located at the base of the mountains, about 12 km in from the coast and on stiff soil, the ground motions in the center of Padang, on softer deeper soil deposits, are likely to have been larger. Superimposed with the measured spectral accelerations are design earthquake spectra, described later. Median PGA values from attenuation models for

As shown in Figure 3, in the short period range, the elastic design spectra for the 2002 code are comparable to the spectral accelerations of the measured ground motions, whereas the values from the 1987 code are much smaller. The elastic design spectra shown in Figure 3 are both for hard soil sites; for the softer soil sites in downtown Padang, the spectral values are
