# The *M<sub>W</sub>* 7.0 Haiti Earthquake of January 12, 2010: USGS/EERI Advance Reconnaissance Team Report

By Marc O. Eberhard, Steven Baldridge, Justin Marshall, Walter Mooney, and Glenn J. Rix

Open-File Report 2010-1048

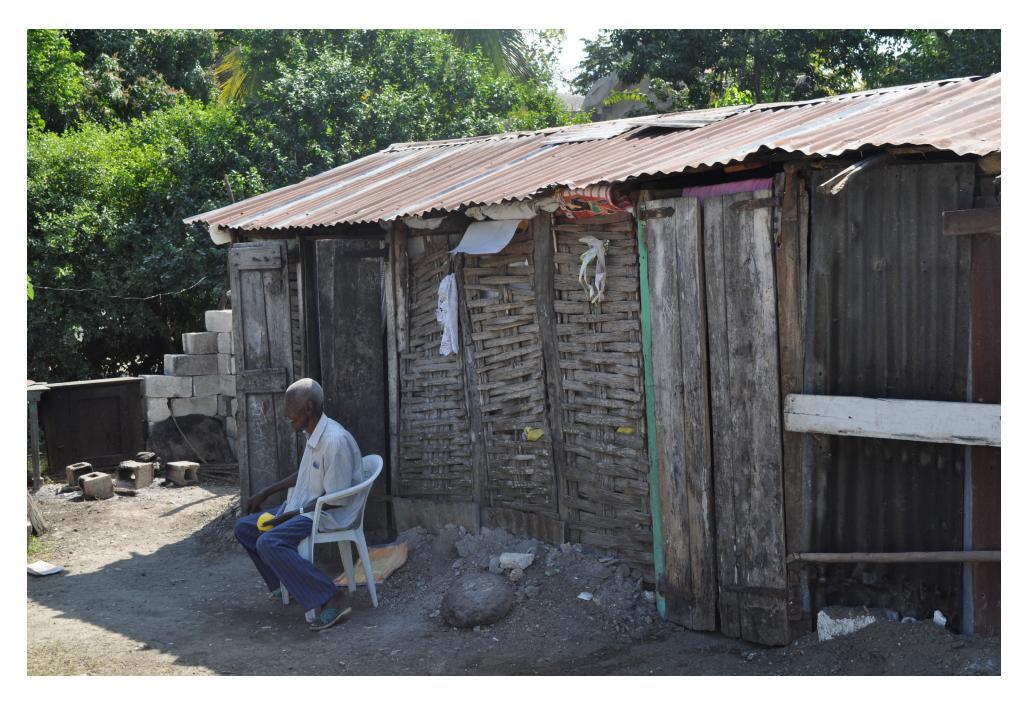
We did not see much damage or collapse in the first two categories of residential construction (fig. 9). The lower weight of the building materials in these types of construction likely resulted in lower seismic inertial forces.

Figure 9. Undamaged light-frame residential building.

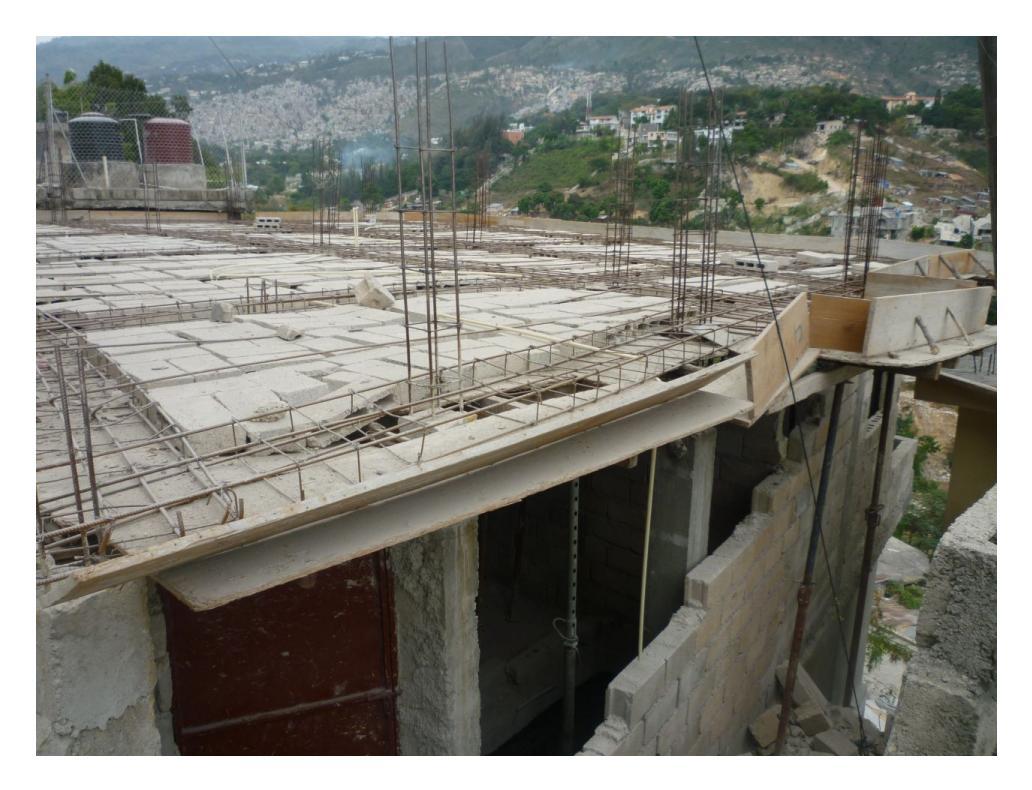
- The slabs and roofs were typically about 150 mm (6 in.) thick and utilized concrete block to create voids in the slabs to reduce the amount of concrete needed. Reinforcing steel was placed between the concrete block void areas to create a system of reinforced ribs in the slab. It appeared that some of this concrete block was placed close to columns, potentially reducing the punching shear capacity of the slab system (fig. 12).

Figure 12. Residential concrete block slab construction.

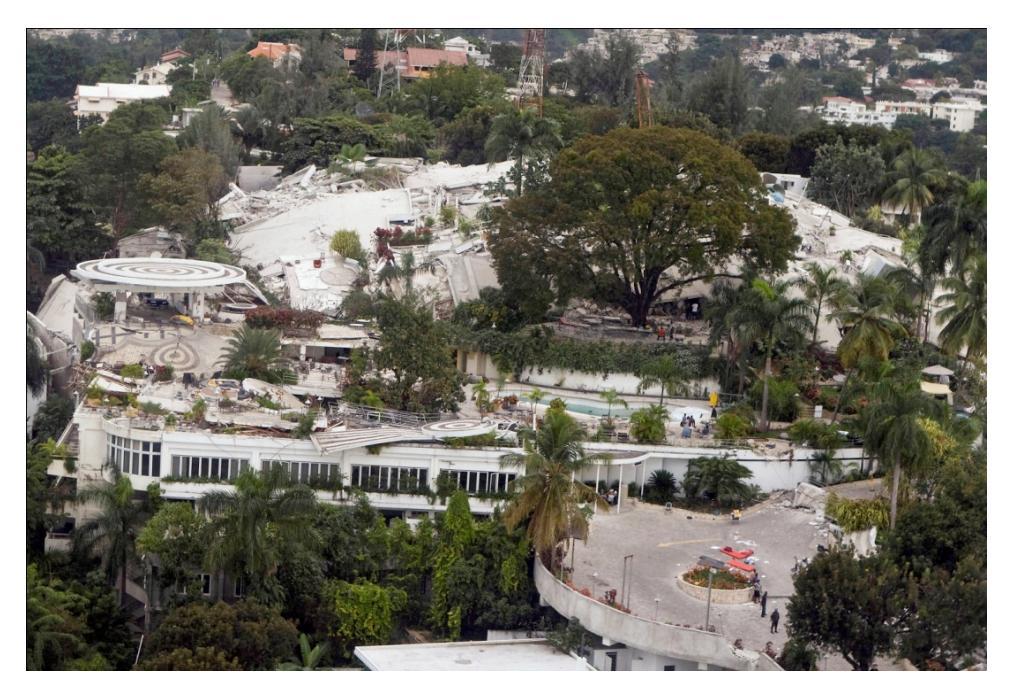
In 1946 the Estimé government organized a bicentenary celebration of the city of Port-au-Prince. Inspired by the event, Frank Cardozo built Hotel Beau-Site, later renamed Hotel Montana. This hotel (18.517586° N, 72.572742° W) celebrated its 60th anniversary in 2006. The original building had 12 rooms; at the time of the earthquake the five-story reinforced concrete hotel had 145 rooms, meeting facilities, and numerous terraces and was known as one of the best hotels in Haiti. The structure was located in the hills of Pétion-Ville and provided beautiful views. The hotel collapsed catastrophically during the earthquake (fig. 16).

Although the Hotel Montana was a high-end property, it appeared to have many of the same vulnerabilities of other concrete construction in Haiti. Heavy, unreinforced concrete masonry walls added weight to the structure but only minimal seismic resistance. Other shortcomings included a lack of ductile

**Figure 16.** The Hotel Montana in Port-au-Prince on January 13, 2010. (AP Photo/The United Nations, Logan Abassi)

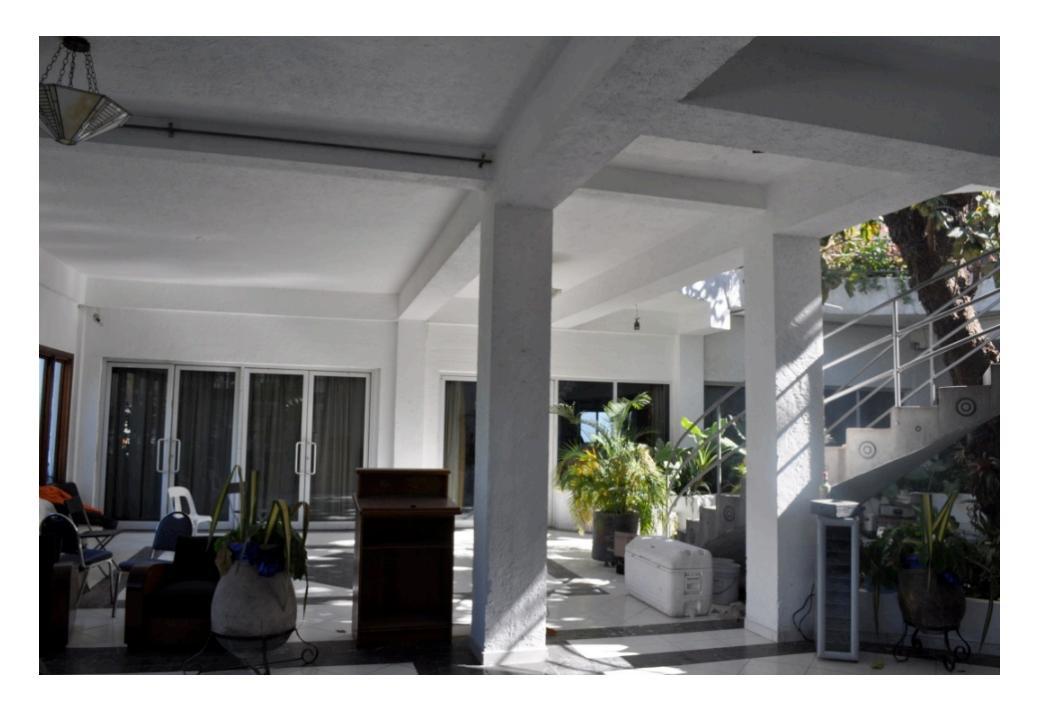
seismic detailing, a mixture of smooth and deformed reinforcing bars with insufficient hook lengths, and questionable concrete quality (figs. 17, 18, and 19). We obtained samples of concrete and reinforcing steel from the Hotel Montana for later strength testing. Only small portions of the hotel remained intact (fig. 20).

**Figure 20.** Areas of the Hotel Montana lobby remained intact. It appeared that this region had reinforced concrete beams and slabs without extensive infill walls.

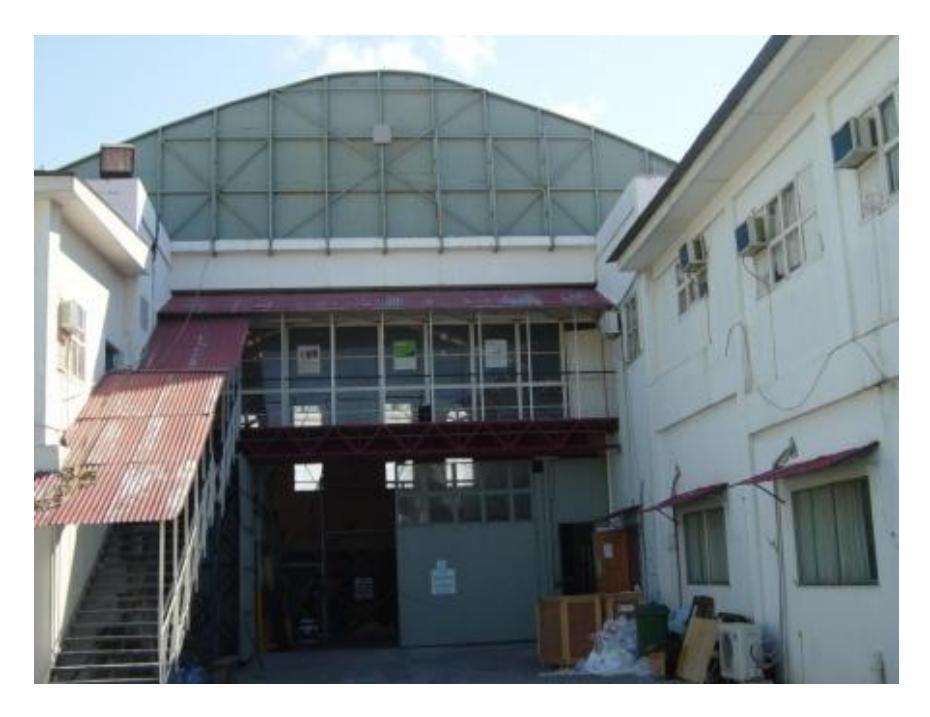
The attached steel-arch warehouse structure performed well. The only damage was non-structural; portions of 1.5-m (5-ft) tall concrete protective wall sections around the interior perimeter tipped over. The other building attached to the steel-arch warehouse (on the left side in fig. 21), which appears to be of the same construction as the CITS Building, experienced similar damage to the exterior wall.

This example suggests that structures could survive the earthquake with little damage, even without seismic detailing, as long as the walls were large enough and had few penetrations.

**Figure 21.** Two-story CITS Building (on right) attached to steel arch structure (in background).

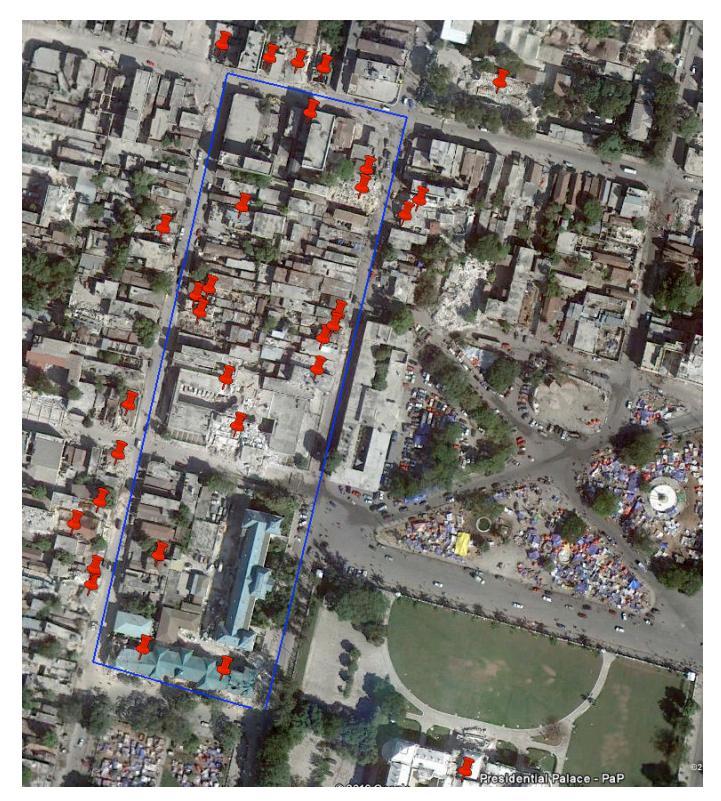
The Port-au-Prince downtown area was significantly damaged, and many structures collapsed. Many of the streets were blocked by the rubble of collapsed buildings. In Port-au-Prince we surveyed 107 structures along a rectangular path with a long side of 350 m (1,150 ft) and a short side of 110 m (360 ft). A total of 42 buildings were assigned damage level 1, 35 were assigned damage level 2, and the remaining 30 represent the number of collapsed structures (level 3). In this section of Port-au-Prince, 28 percent of the structures collapsed, and 61 percent either collapsed or were damaged enough to require repairs. Figure 37 shows the damage map of the Port-au-Prince survey. The blue line shows the route. The southeast corner, adjacent to the National Palace, was where the survey commenced (18.543576° N, 72.339897° W). The red pushpins represent structures of damage level 3. The National Palace was not included in our survey; it is shown only for reference.

**Figure 37.** Damage map indicating collapsed structures (red) along the surveyed route in Port-au-Prince (Source of base photo: Google Earth).

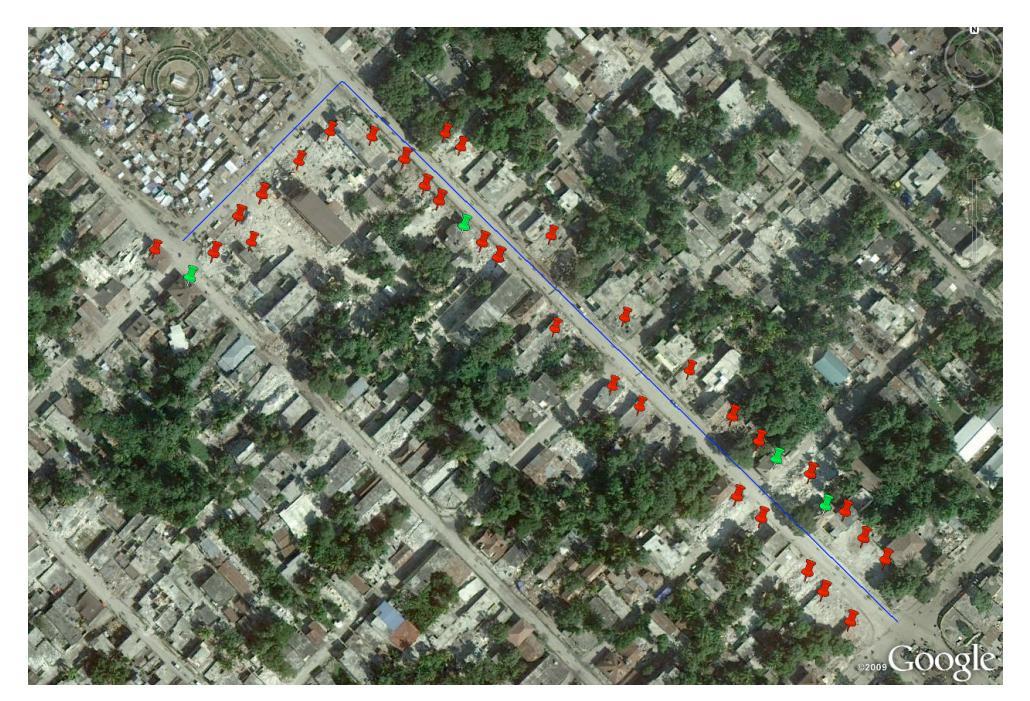
Léogâne is the closest significant population center to the epicenter of the earthquake (approximately 11 km or 7 mi). In Léogâne we surveyed 52 structures along an L-shaped route with a long side of 380 m (1,250 ft) and a short leg of 110 m (360 ft). In this area, only four structures met the criteria for damage level 1. Sixteen structures were classified as damage level 2, and the remaining 32 structures (62 percent) were collapsed to some degree. A damage map of the Léogâne route is shown in Fig. 38. The green pushpin markers represent the level 1 structures. The red pins represent the partially or totally collapsed structures (damage level 3). The walking route, shown with the blue line, began at the southeast road intersection (18.508687° N, 72.629998° W).

**Figure 38.** Damage map indicating collapsed (red) and undamaged (green) structures along the surveyed route in Léogâne (Source of base photo: Google Earth).

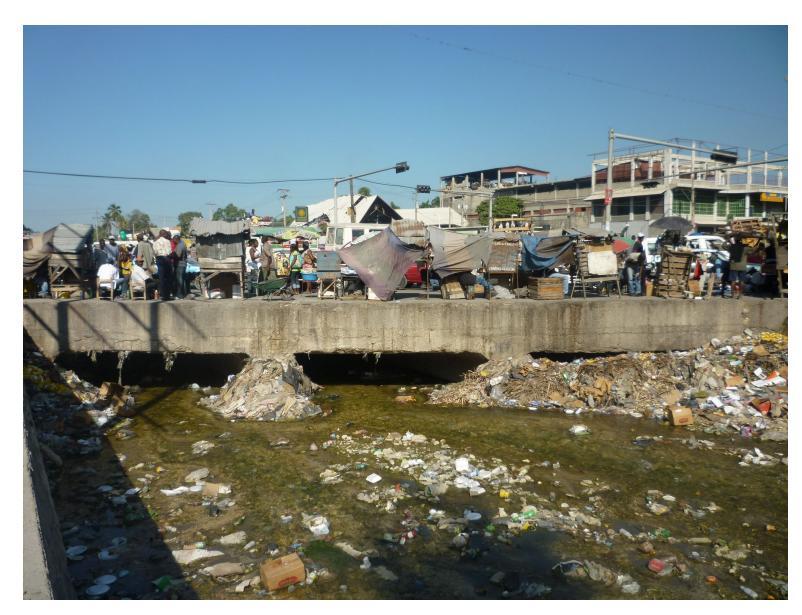
We did not see or learn of any bridge collapses attributable to the earthquake. Within Port-au-Prince, most of the crossings over streams were accommodated by box culverts 2-2.5 m (6-8 ft) deep, which did not appear to be damaged. These crossings may nonetheless be hazardous in the future, because the large amount of garbage that has accumulated upstream of these culverts may combine with silt and debris to prevent water from passing through the culverts. Once rains return to Port-au-Prince, the overflow of these culverts may pose a health hazard to displaced residents, some of who are living on or near these culverts (fig. 39).

Figure 39. View of box culvert in Port-au-Prince, looking downstream.

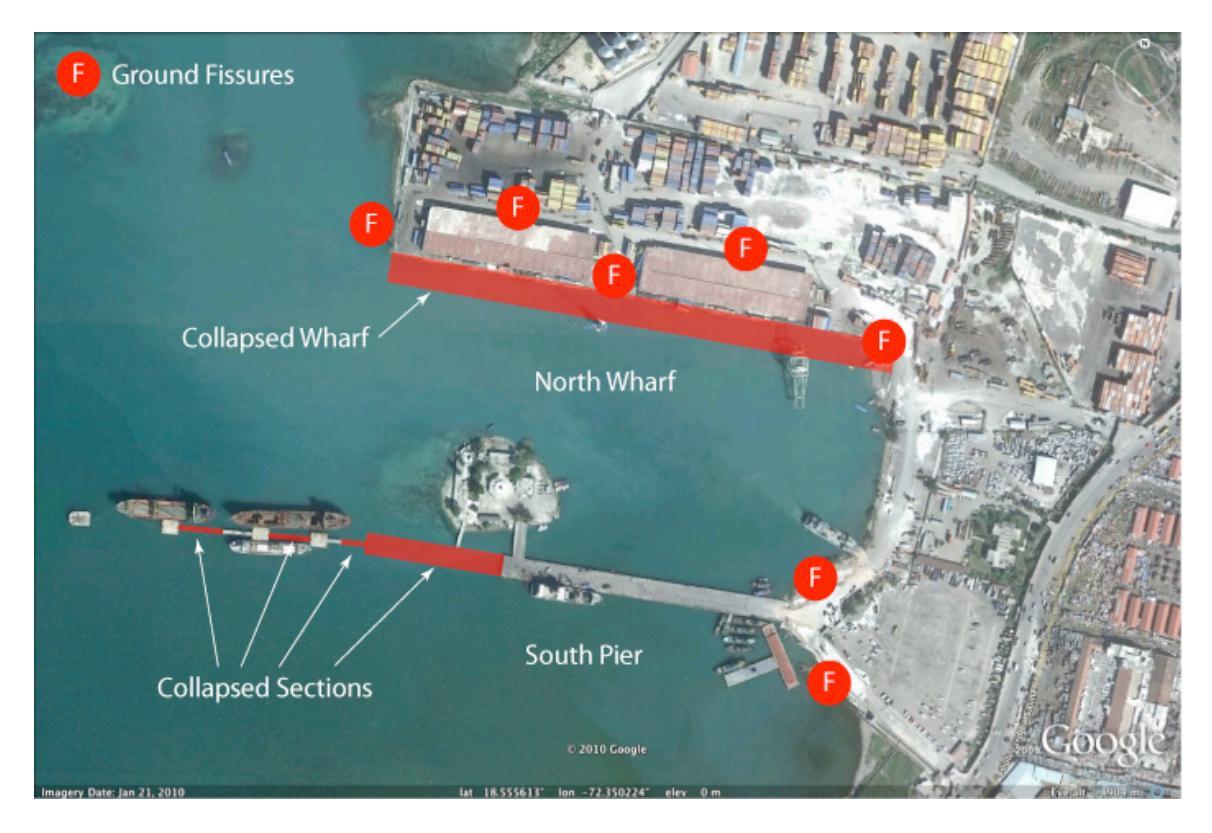
Figure 42. Annotated aerial image of Port de Port-au-Prince (Google Earth).

The North Wharf collapsed, most likely due to liquefaction-induced lateral spreading. Numerous surface manifestations of the liquefaction are present in the vicinity of the North Wharf. Light-colored areas in figure 42 are sand boils and can be seen in the eastern half of the container storage yard and behind and between the two warehouses. The locations where large lateral spreading fissures were observed are shown in figure 42 with symbols. Figure 43 shows two examples of these fissures at the eastern and western ends of the wharf area.

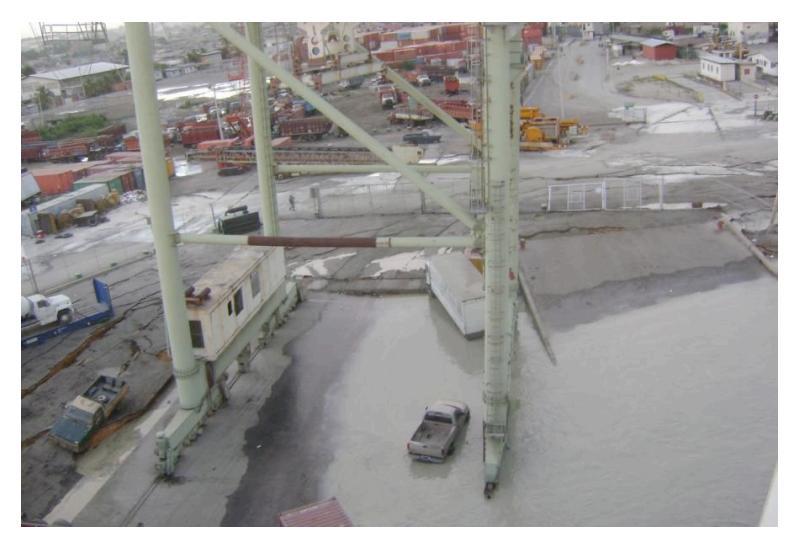
**Figure 45.** Photo taken immediately after the earthquake showing the landside legs of the crane above water. (Source: James Bobbitt, BP Shipping USA).

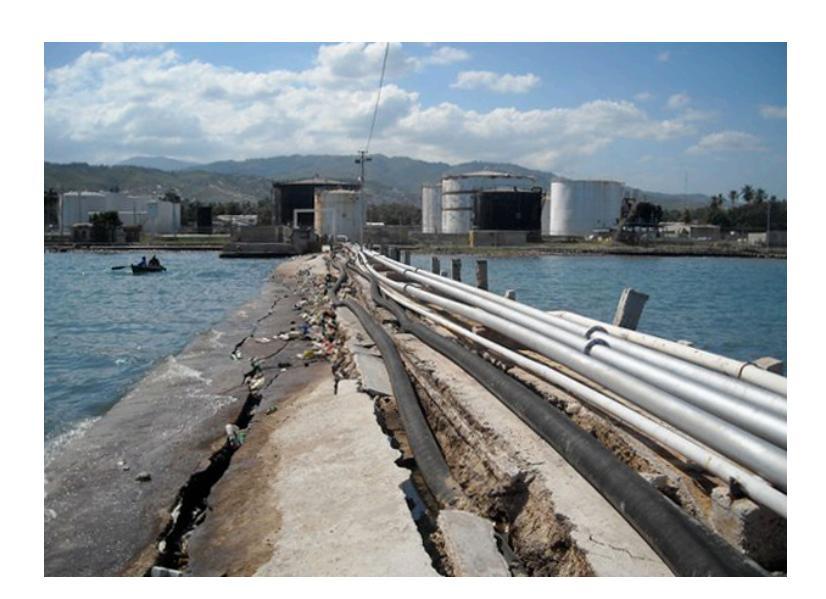
At the Thor marine oil terminal (18.540528° N, 72.385710° W) one portion (approximately 230 m or 1,500 ft long) of the pipelines used to offload petroleum products is supported on an embankment constructed out into the water, and a second portion (approximately 120 m or 400 ft long) is supported on piles. The pile-supported portion was undamaged, but the embankment-supported portion experienced some damage due to vertical displacement of the embankment, as shown in figure 49 (Scott Chodkiewicz, personal commun., 2010). The damage was not serious enough to prevent use of the pipelines following the earthquake.

**Figure 49.** Embankment-supported petroleum pipelines at the Thor marine oil terminal. (Source: Scott Chodkiewicz, U.S. Army Corps of Engineers)

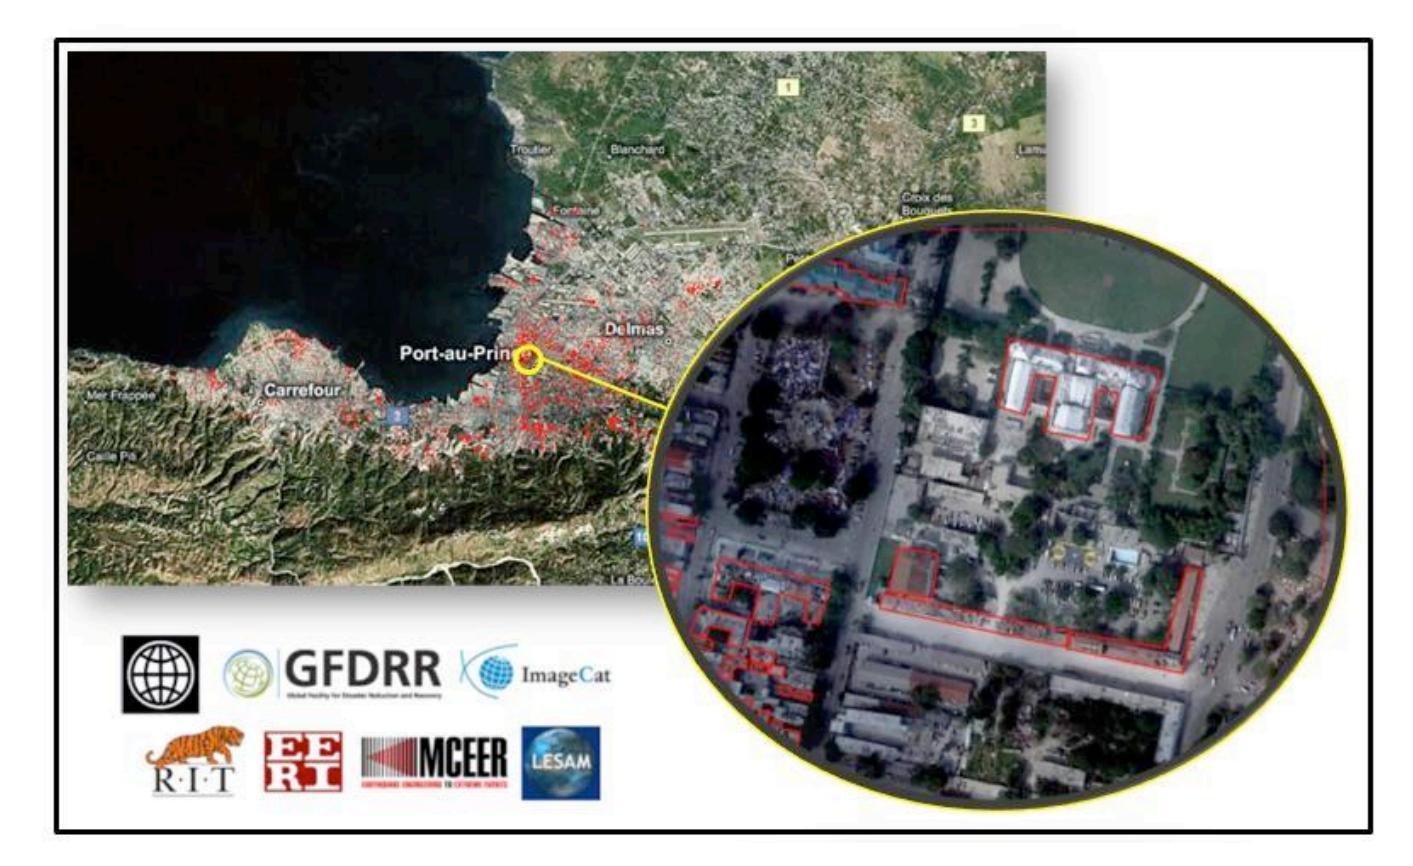
A unique aspect of the response to this earthquake has been the extensive use of remote sensing data, including satellite imagery and aerial photography, to guide damage assessment, rescue and recovery efforts. The organizations involved in these efforts include ImageCat, the World Bank's Global Facility for Disaster Reduction and Recovery, the Rochester Institute of Technology, the Earthquake Engineering Research Institute, and MCEER. ImageCat, in collaboration with other partners, formed the Global Earth Observation Catastrophe Assessment Network (GEO-CAN). This network is using very high resolution aerial and satellite imagery to determine which structures have completely or partially collapsed or are heavily damaged. Their findings have been and will be used by the World Bank to help develop plans for the reconstruction effort. The damage assessment is being done by volunteer scientists and engineers in government, academia, and private practice who are comparing previous imagery with the high-resolution imagery captured after the earthquake. More than 500 skilled engineering personnel in remote locations have participated in damage assessment to date. They have also used light detection and ranging (LIDAR) technology to create a three-dimensional map of the region to further enhance their knowledge of the damage. An example of the damage map from ImageCat and GEO-CAN is shown in figure 54. The red lines in the figure indicate structures that have sustained damage discernable from the imagery.

Figure 54. Sample of Damage Assessment Map.

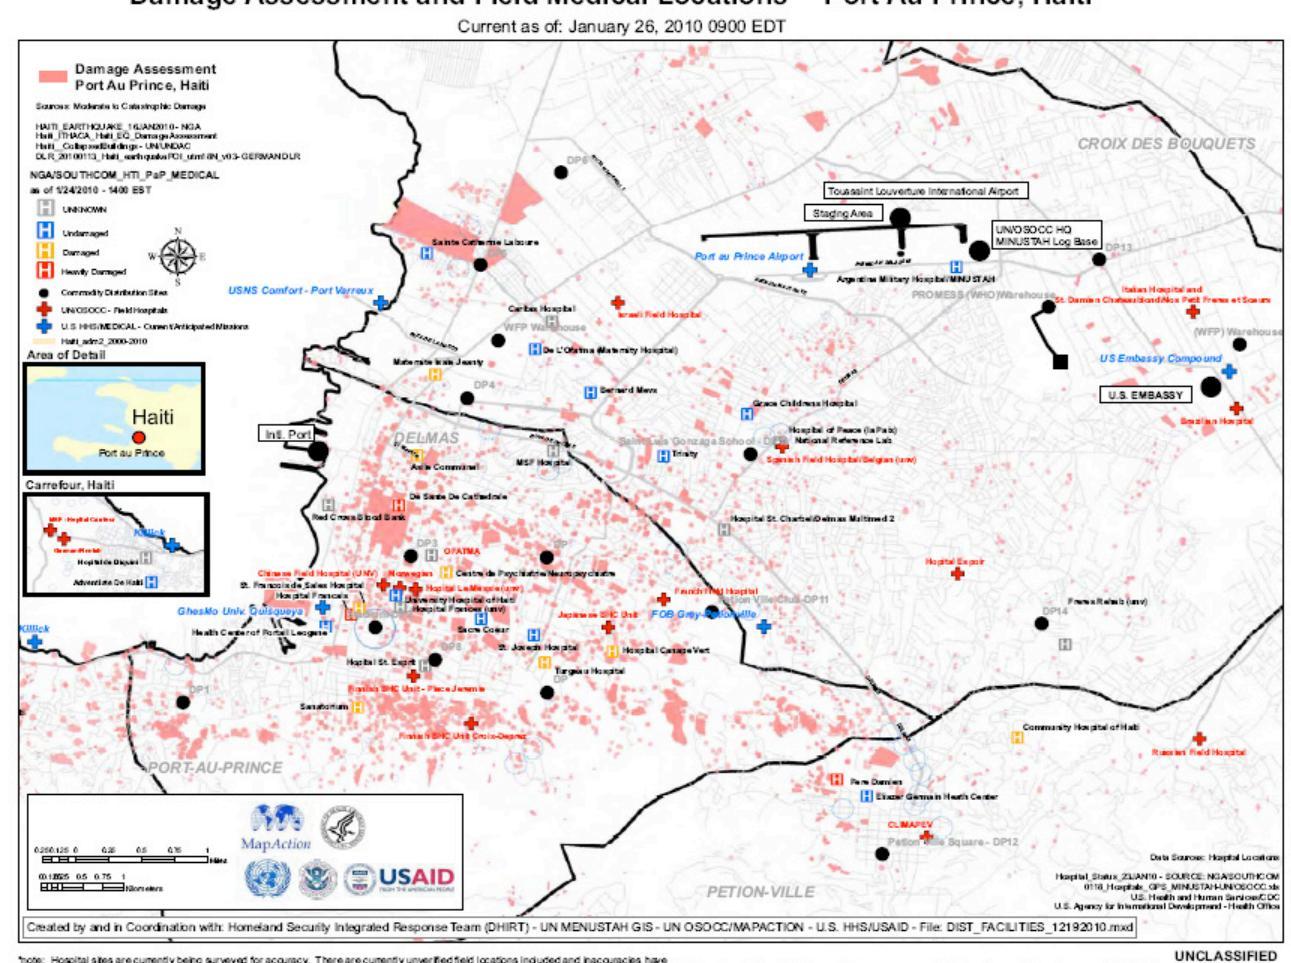
Figure 55. Damage assessment and field medical locations (Relief Web, 2010).

Many of these organizations have made their imagery available to those who are involved in the recovery and rebuilding efforts. For example, figure 55, which shows damage assessment and field medical locations for Port-au-Prince, is an example of collaboration among these agencies. This figure combines the information provided by the SOUTHCOM-NGA, ITHACA, UNOSAT, and German DLR. It was created by and in coordination with the U.S. Department of Homeland Security, the UN, and USAID (ReliefWeb, 2010).

Damage Assessment and Field Medical Locations\* - Port Au Prince, Haiti
